HEREWEKA HARBOUR CONE

CONSERVATION PLAN
2020
PETER PETCHEY & JILL HAMEL

HEREWEKA HARBOUR CONE
OTAGO PENINSULA
CONSERVATION PLAN
2020

PETER PETCHEY
SOUTHERN ARCHÆOLOGY LTD.

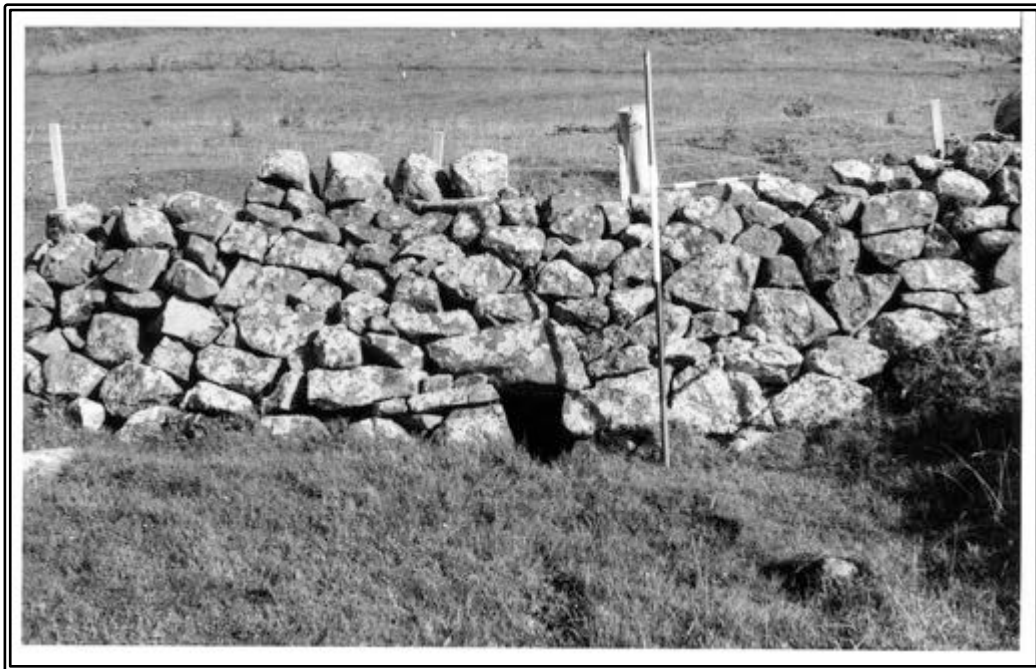
This drystone wall complex marks the northern boundary of the Harbour Cone purchase. The wall is well-constructed, but now in mixed condition, with some very well preserved sections and some poor sections. In particular in one place a slow landslide has caused the wall to collapse and its line to bow out from the legal boundary. There are approximately 900 metres of the wall along the property boundary (Higham walls 21A, 21B), and another 95 metres of wall on neighbouring land connects to the wall (Higham wall 21C).

Figure 6
Stone wall I44/410: Wall 21A illustrated in Higham 1986, showing a water smoot through the wall.

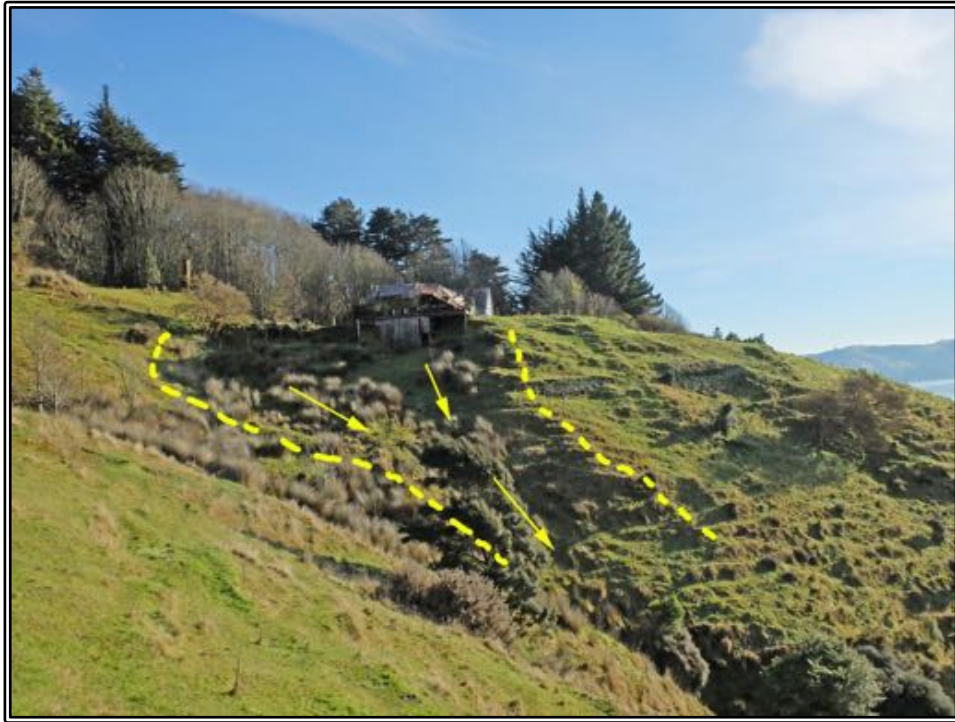
Figure 26

- Condition: Site generally good.
Drainage down drive and onto flat, and ground water, causing dampness. May exacerbate instability of terrace edge.
Byre discussed in Section 5 below. Moderate condition.
- Threats: Instability.
Decay of byre building.
Stability of brick chimney.
- Tree management: Maintenance of trees on hillside to west of farmstead.

The slip on the south side of Larnach's farmstead terrace. This slip appears to have been slowly active since the terrace was first created, and caused the loss of the original implement shed.

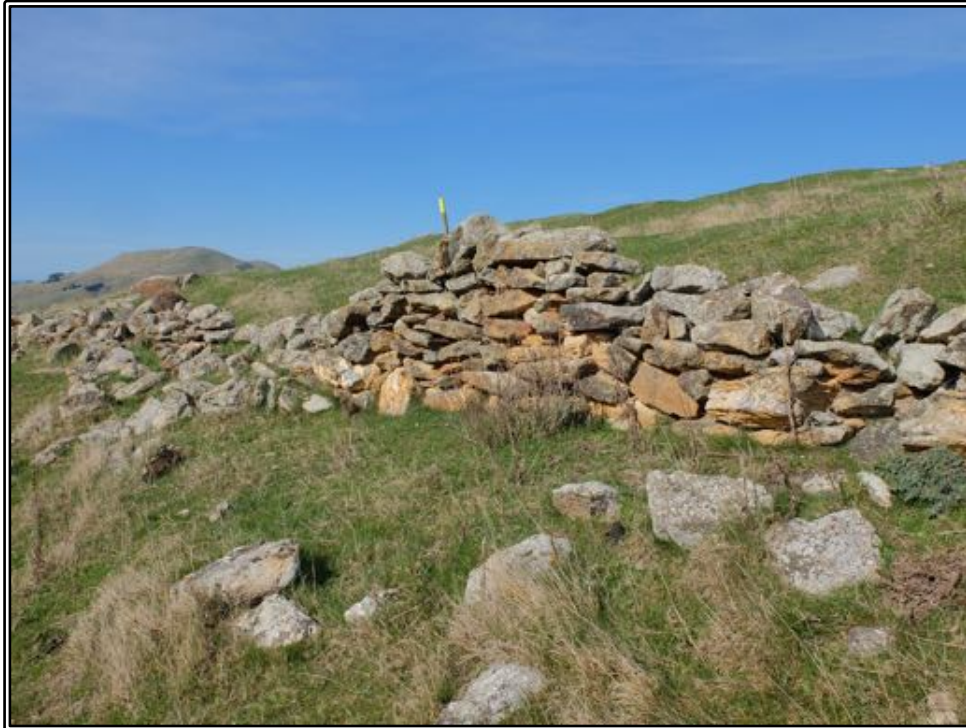
A stone wall in moderate to poor condition runs beside the track to the gold mine (I44/424), along the boundary between Rutherford's and Nyhon's properties. The wall is only present across the top of the hill, and fades away once the track heads downhill. This was identified by Higham (1986) as Wall 3C.

Figure 97
Stone wall I44/1017 beside the track to Battery Creek.

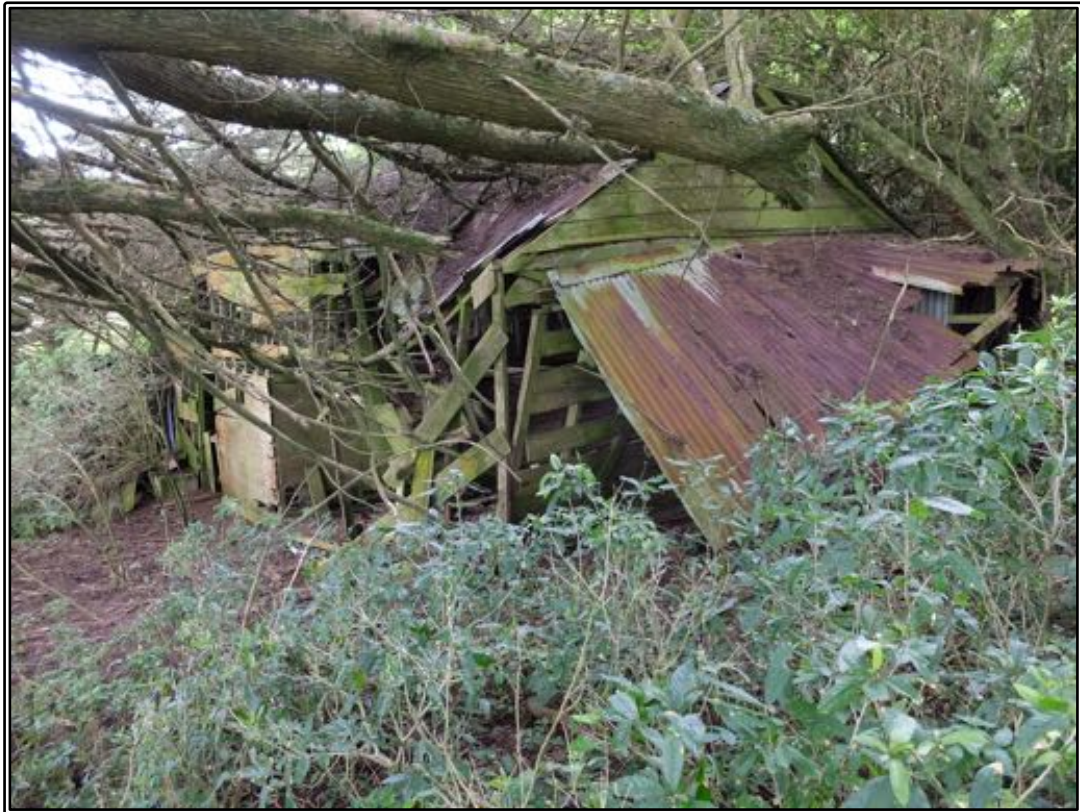
Condition: Site, good. Building, very poor (see Section 5 below).

Threats: Unsafe building. Macrocarpa trees.

Figure 168
The north end of Riddell's farm building in 2020, showing the partial collapse and damage from macrocarpa limbs.

Tree management: Prune macrocarpas along front of farmstead site.

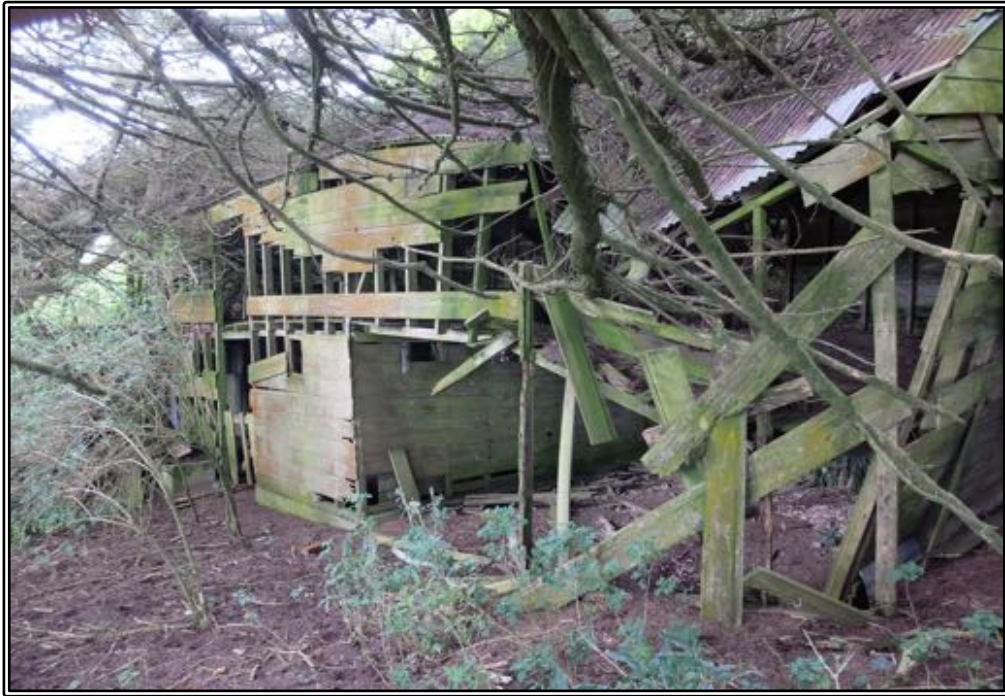
Figure 169
The front (east) wall of Riddell's farm building in 2020, showing the partial collapse of the structure.

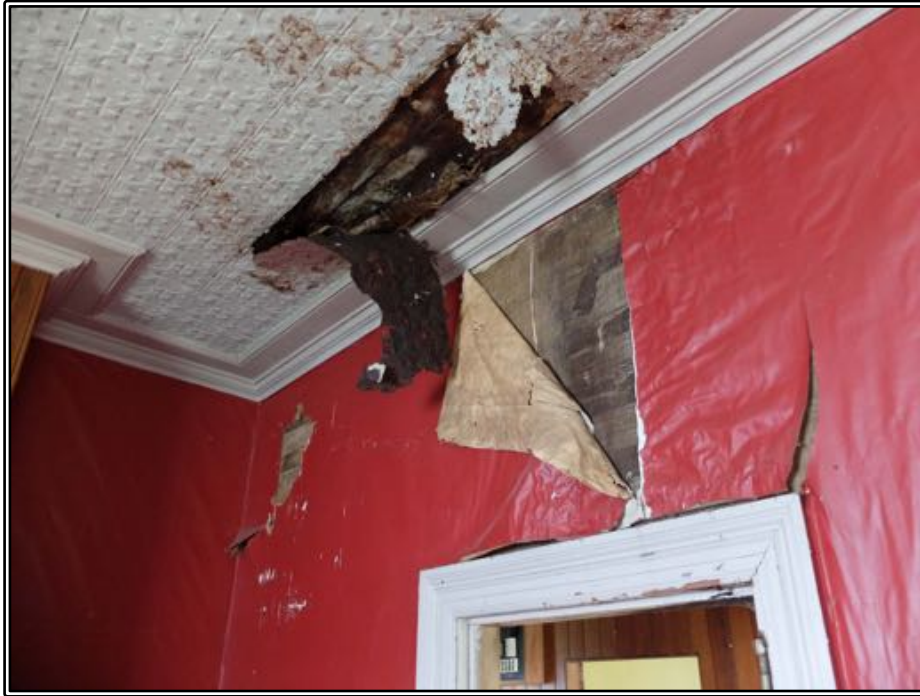
Figure 201
Inside the front eastern room of Roger's house, showing the effect of the leaking roof.
The ceiling was pressed thin iron sheets over timber.

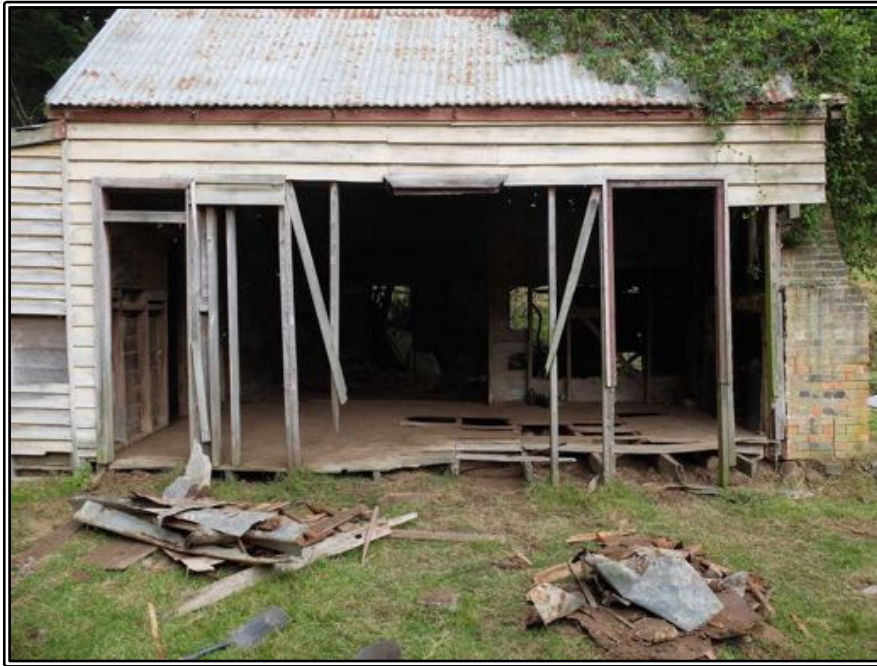
Figure 205
The front wall of the original section of Stewart's house, after the interior was cleared out. Despite the missing framing and cladding the front of the house is still standing reasonably square and level.

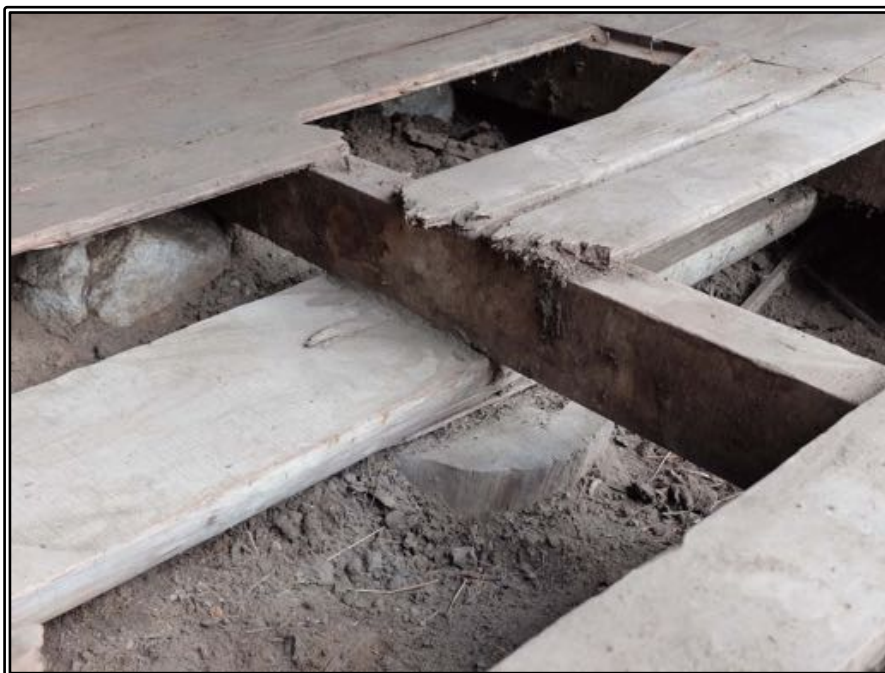
Figure 206
The sub-floor structure of Stewart's house where it has been exposed by broken floorboards. A full-round pile supports a half-round bearer, which in turns carries the floor joists and floorboards. All timbers are pit-sawn.

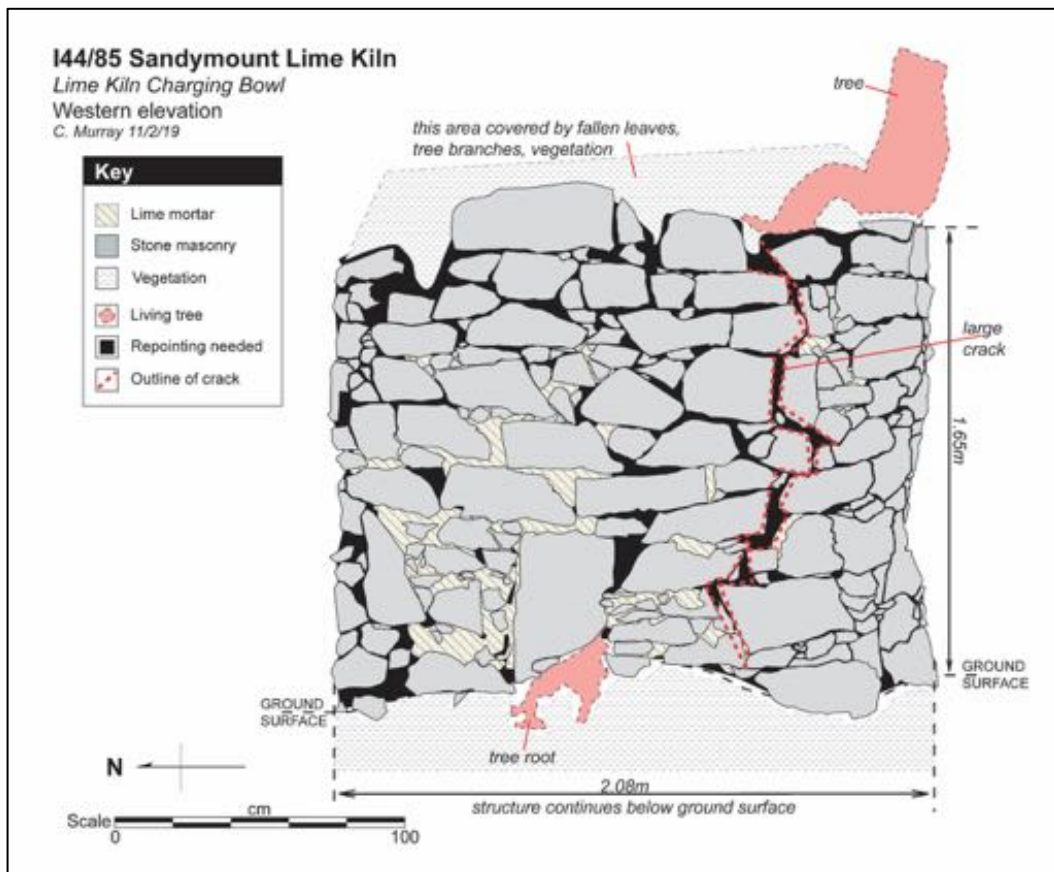
Condition: Kiln: Moderate, with severe cracking, requires intervention.
 Site: Good.
Threats: Stock trampling, especially cattle around lime kiln base and sides.
Tree management: Vegetation growing in and round kiln requires removal, but this needs careful management to prevent mechanical damage.

Figure 216
Western elevation of the kiln showing the top section of the structure (charging bowl). A large crack is present in the masonry and a tree is growing on top of the drum with a large root protruding through the base of the structure (Murray & Griffiths 2019).
