HEREWEKA HARBOUR CONE

CONSERVATION PLAN
2020
PETER PETCHEY & JILL HAMEL

HEREWEKA HARBOUR CONE
OTAGO PENINSULA
CONSERVATION PLAN
2020

PETER PETCHEY
SOUTHERN ARCHÆOLOGY LTD.

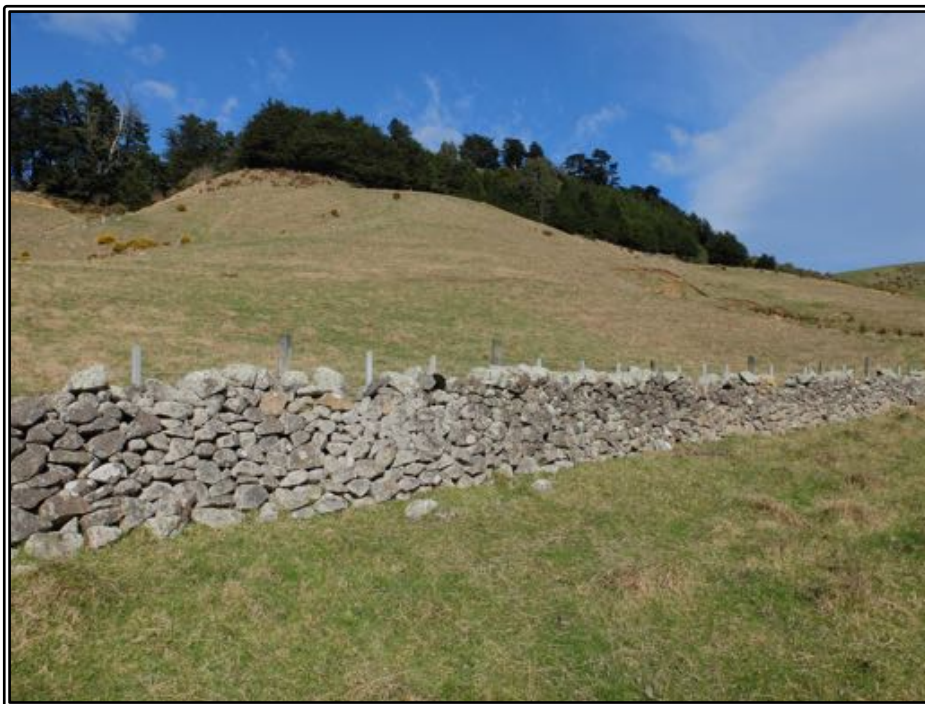
Figure 8
One of the best-preserved sections of stone wall I44/410.

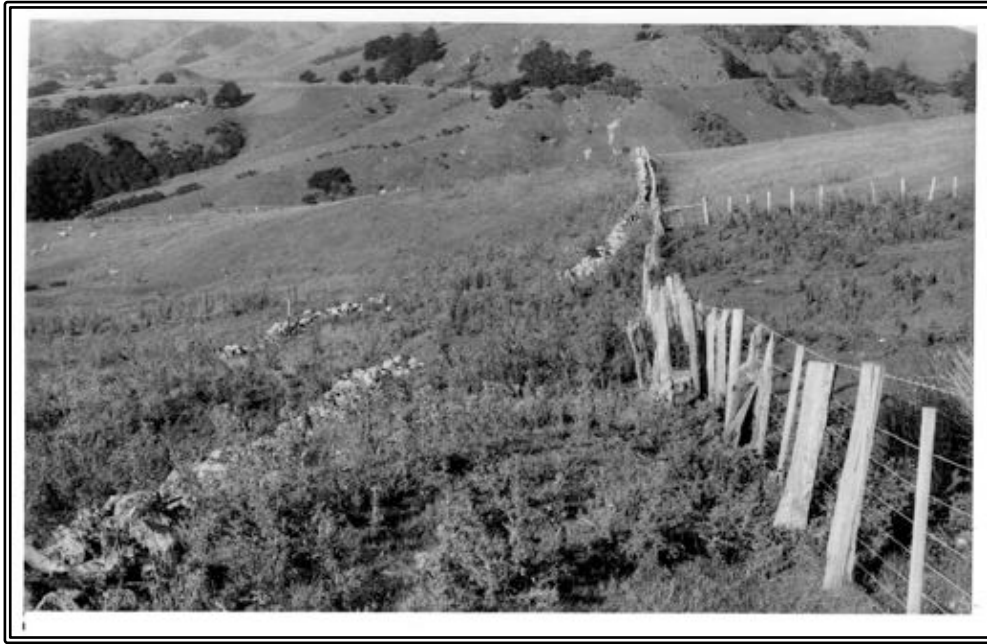
Figure 9
The section of wall I44/410 affected by slumping as it appeared in 1986 (Higham 1986, Wall 21A).

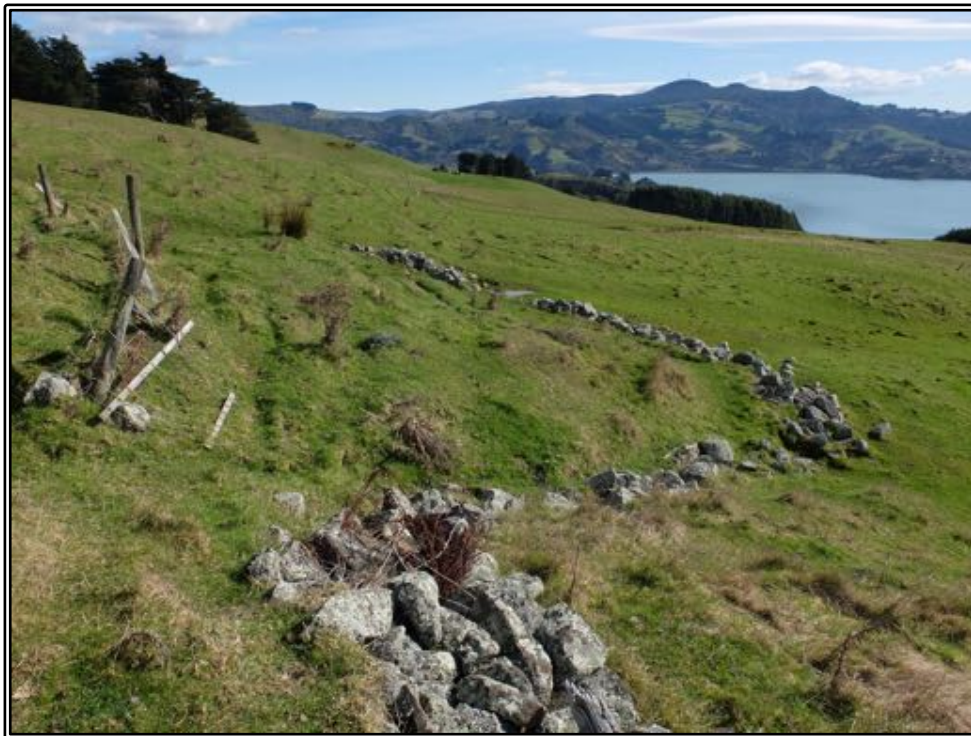
This drystone wall complex marks the northern boundary of the Harbour Cone purchase. The wall is well-constructed, but now in mixed condition, with some very well preserved sections and some poor sections. In particular in one place a slow landslide has caused the wall to collapse and its line to bow out from the legal boundary. There are approximately 900 metres of the wall along the property boundary (Higham walls 21A, 21B), and another 95 metres of wall on neighbouring land connects to the wall (Higham wall 21C).

Figure 10
The section of wall I44/410 that has been displaced by slumping. Comparison with the image above taken in 1986 suggests that the ground may still be slowly moving.

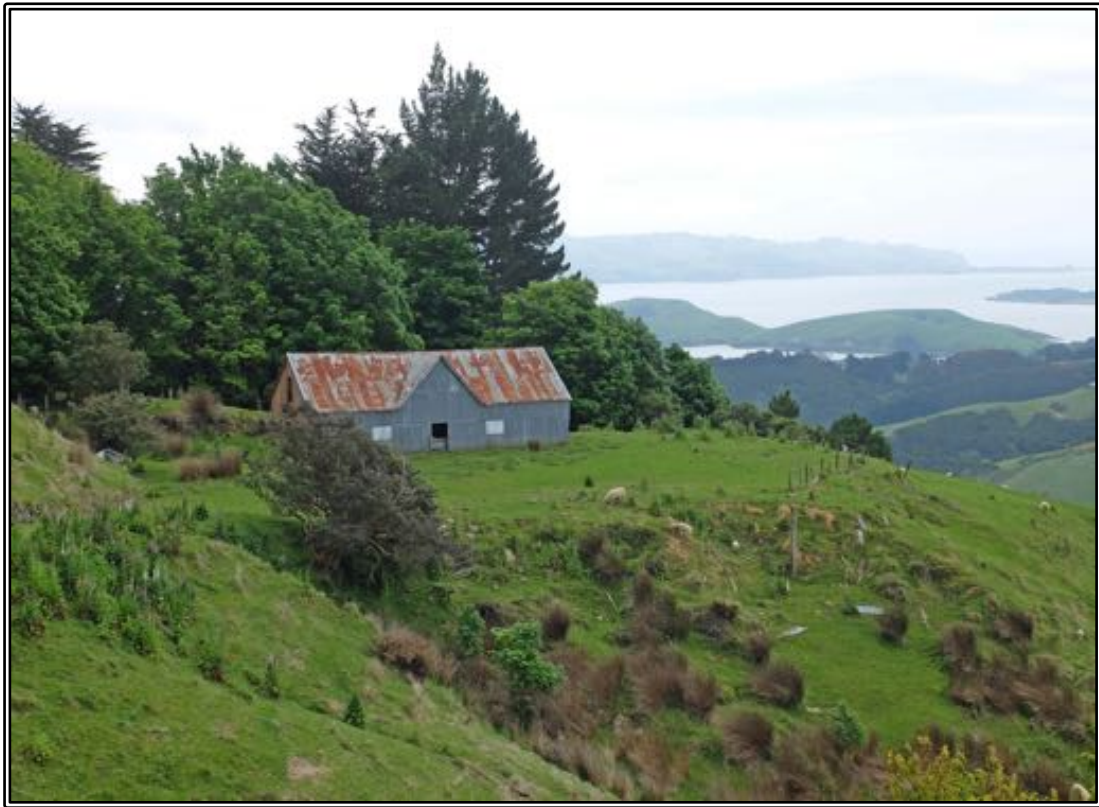
Figure 18

Larnach's farmstead in 2020. The only standing building is now the large cow byre.

- Condition: Site generally good.
Drainage down drive and onto flat, and ground water, causing dampness. May exacerbate instability of terrace edge.
Byre discussed in Section 5 below. Moderate condition.
- Threats: Instability.
Decay of byre building.
Stability of brick chimney.
- Tree management: Maintenance of trees on hillside to west of farmstead.

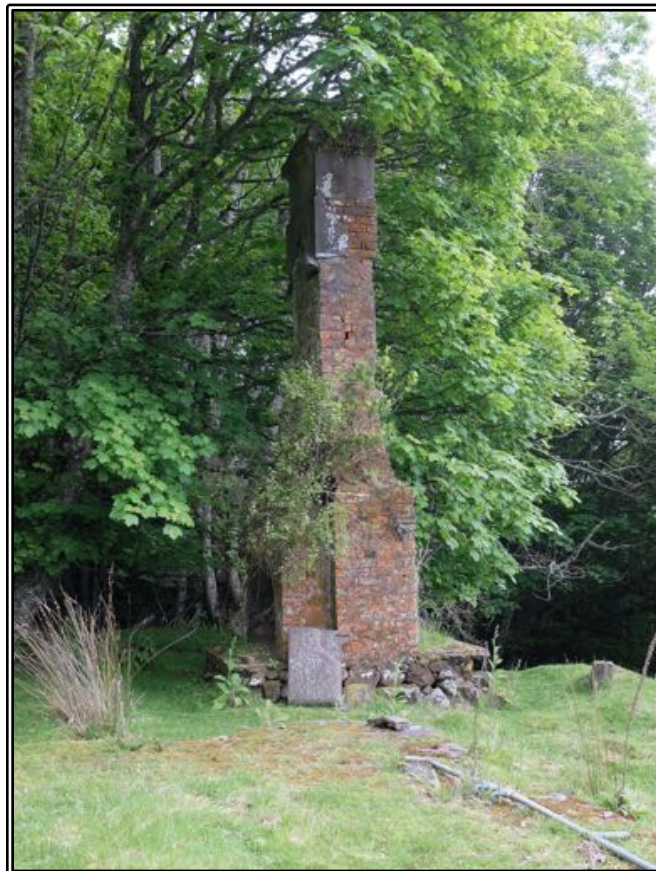
Figure 20

The brick chimney of Larnach's farm manager's house.

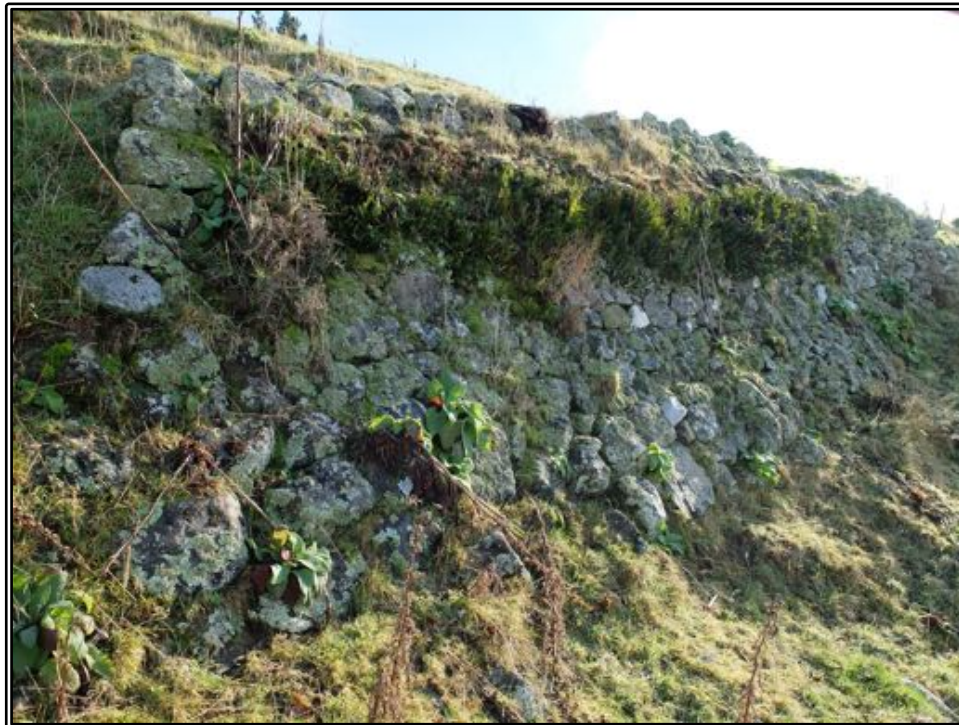
Figure 27

One of the sections of revetment on the southern face of Larnach's farmstead terrace, probably built in an attempt to stabilise this slope.

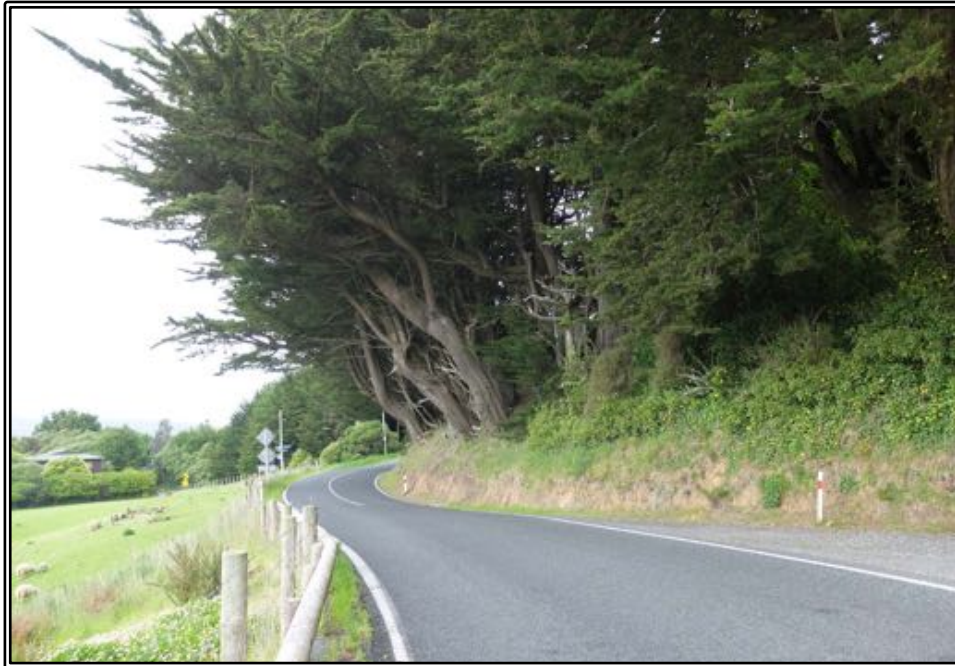
Figure 32
The trees at Riddell's farmstead (I44/414), overhanging Highcliff Road.

Threats: Unsafe building. Macrocarpa trees.

Tree management: Prune macrocarpas along front of farmstead site.

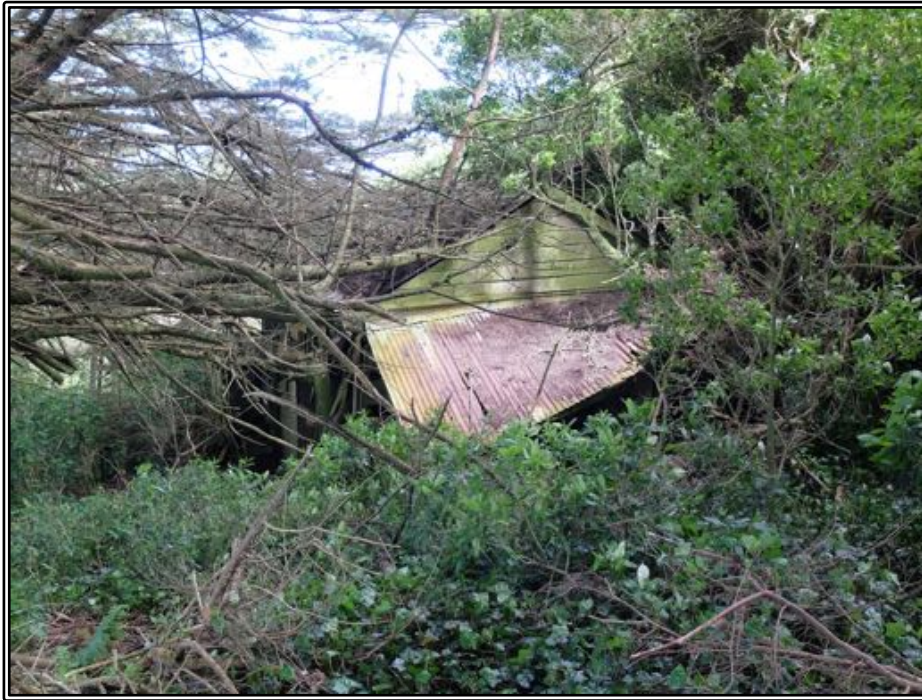
The farm building was a two storied stone and wooden structure, and combined the functions of a barn, stables and byre, and also has a small lean-to on the front that was probably used as the local Post Office. The building is still partially standing, but is in very poor condition, with the byre end having been demolished by a falling tree. It was built to incorporate a stone retaining wall against the rear bank of the terrace. The building is described in detail in Section 5 below.

Figure 34
The north end of Riddell's farm building. The building collapse, aided by descending macrocarpa branches, is apparent.

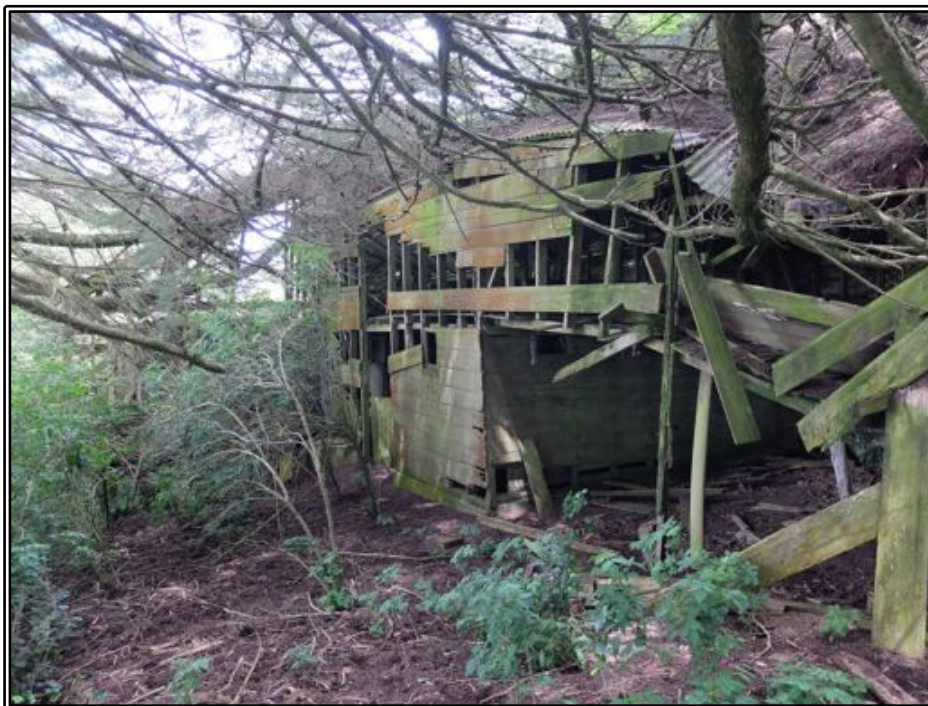
Figure 35
The front of Riddell's barn/byre/stables building. The centre section of the building is still standing, but the far end (south, the byre section) has collapsed after a tree fell through it.

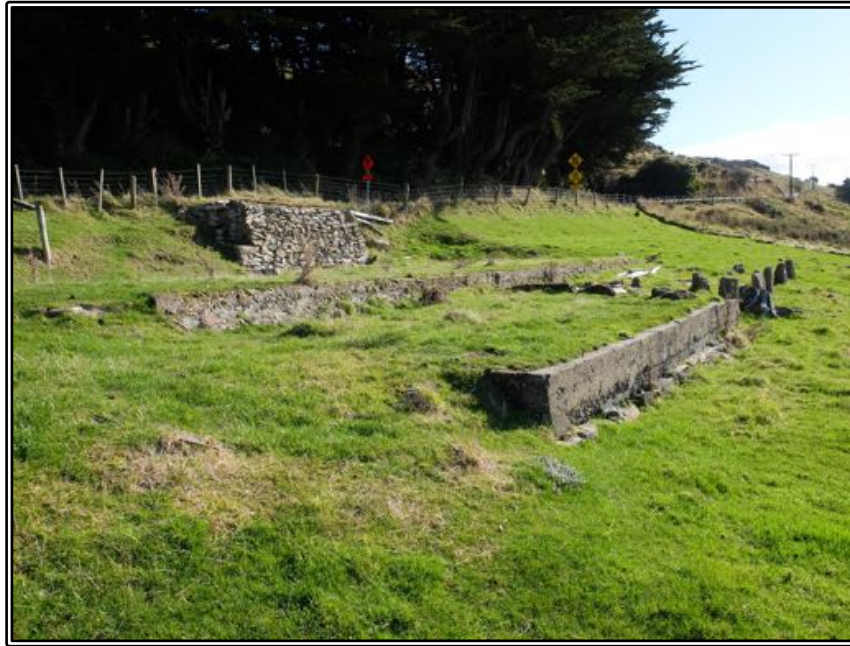
Figure 42
The concrete and stone foundations of the limestone crushing plant I44/447.

The site is located on the downhill side of the Highcliff Road, adjacent to the junction with the Sandymount Road and opposite Riddell's farmstead site (I44/414). The concrete foundations for a building of approximately 17m by 8m, with a 4m extension out to the side, are clearly visible in the grassy field. A substantial stone revetment has been built under the Highcliff Road in one place, possibly to support a loading bay, and an access drive off Sandymount Road is still evident.

Condition: Reasonable (foundations only).
Threats: None known.
Tree management: N/A

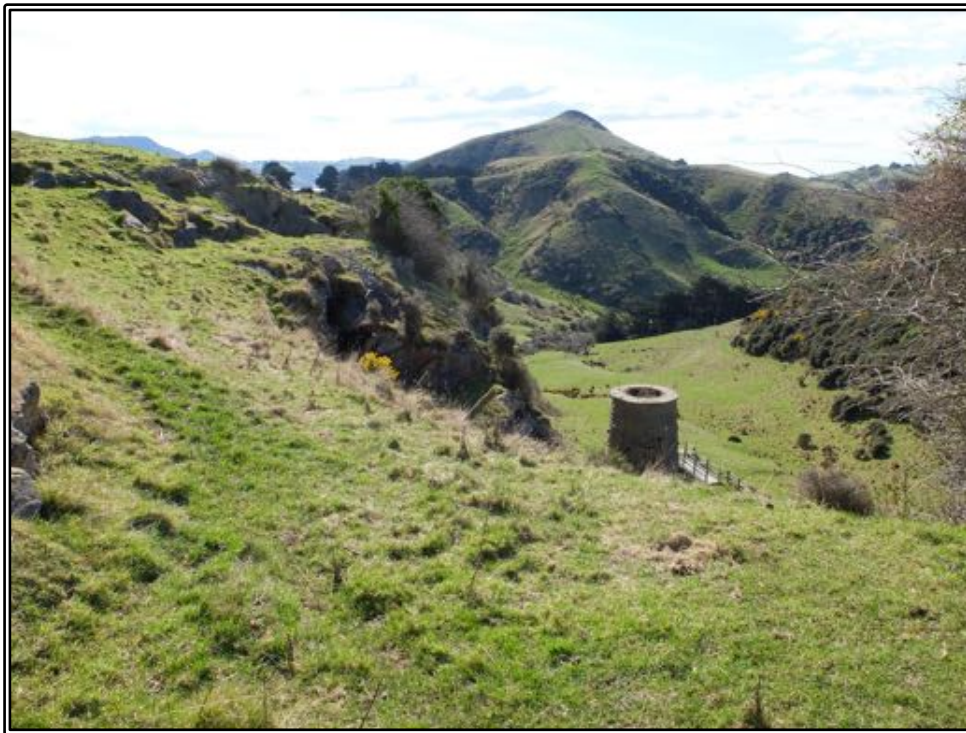
Figure 44

The tramway is in open grazed pasture, and consists of robust earthworks. Some soil slipping is apparent near the central section of the tramway. This may continue, and stock damage from cattle is possible.

Condition:	Good. Minor slumping.
Threats:	Slumping. Heavy stock may exacerbate.
Tree management:	N/A

The tramway formation I44/81 (on left of image) leading around to Limekiln I44/84.

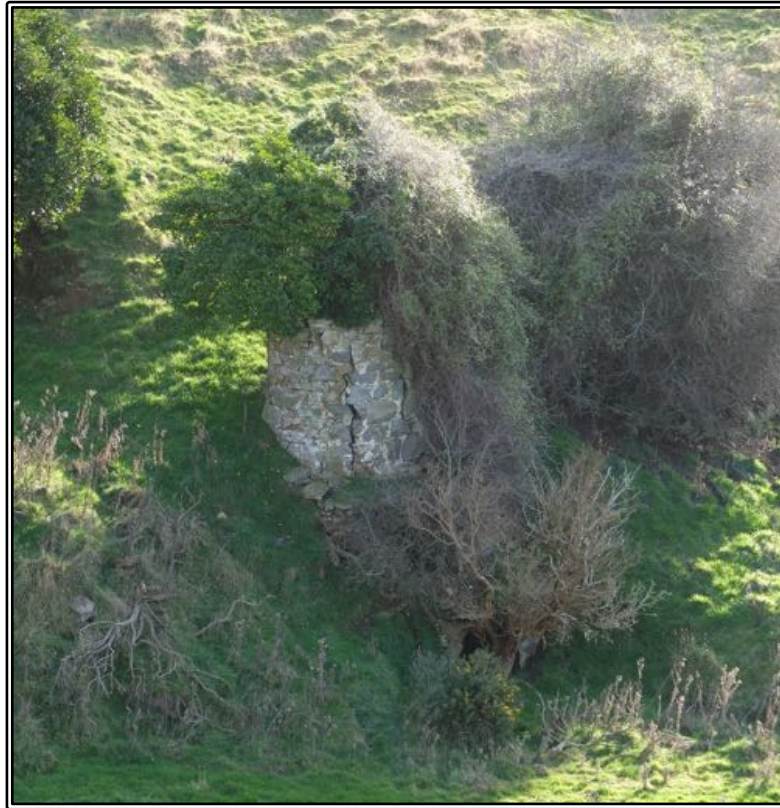
Figure 46
The bottom lime kiln (I44/85), set into the hillside and presently overgrown.

Condition: Kiln: Moderate, with severe cracking, requires intervention.
 Site: Good.
Threats: Stock trampling, especially cattle around lime kiln base and sides.
Tree management: Vegetation growing in and round kiln requires removal, but this needs careful management to prevent mechanical damage.

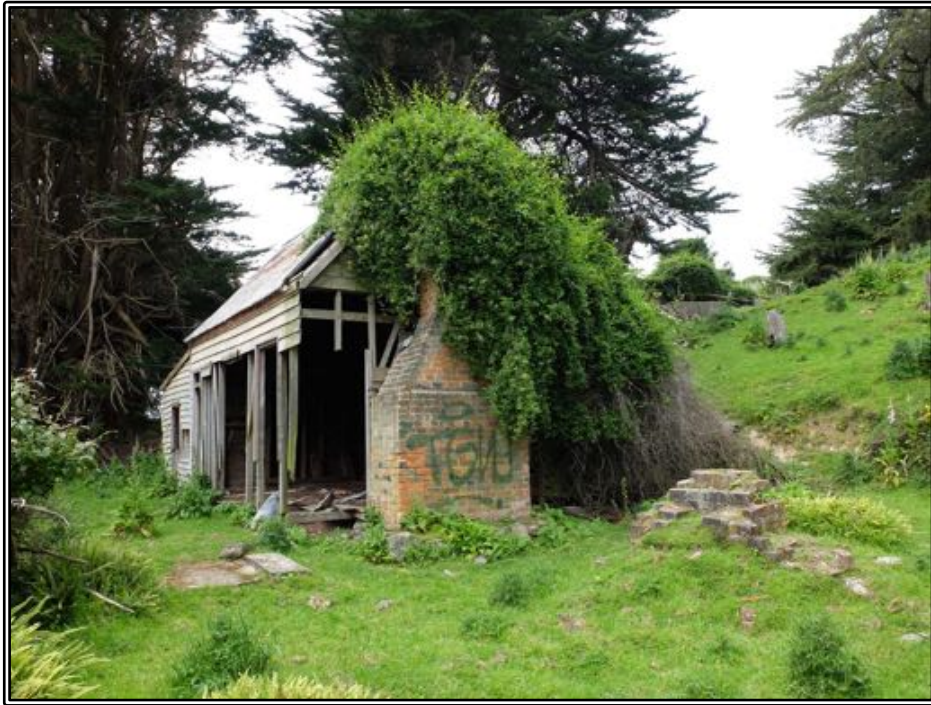
Figure 56
Stewart's house, with the brick foundations of another building in the right foreground.

Condition: House, moderate to poor (see Section 5). Overall site good.
Threats: Treefall on house. Stock in house. Fossicking/theft (engine).
Tree management: Prune marocarpos, with greatest priority on those that threaten house.
General vegetation control around house.

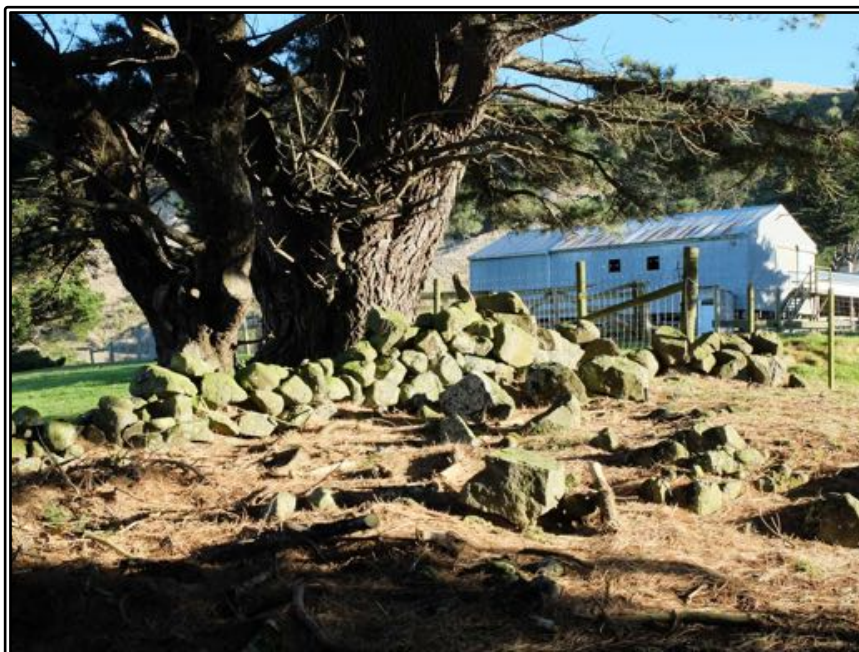
Figure 60
Remains of stone wall or enclosure, east end of Roger's farmstead site, with the modern woolshed in the background.

Condition: Byre reasonable, House poor (see Section 5). Overall site reasonable.
Threats: Modern farming requirements.
Deterioration of buildings.
Tree management: Maintenance of large trees. Not urgent.

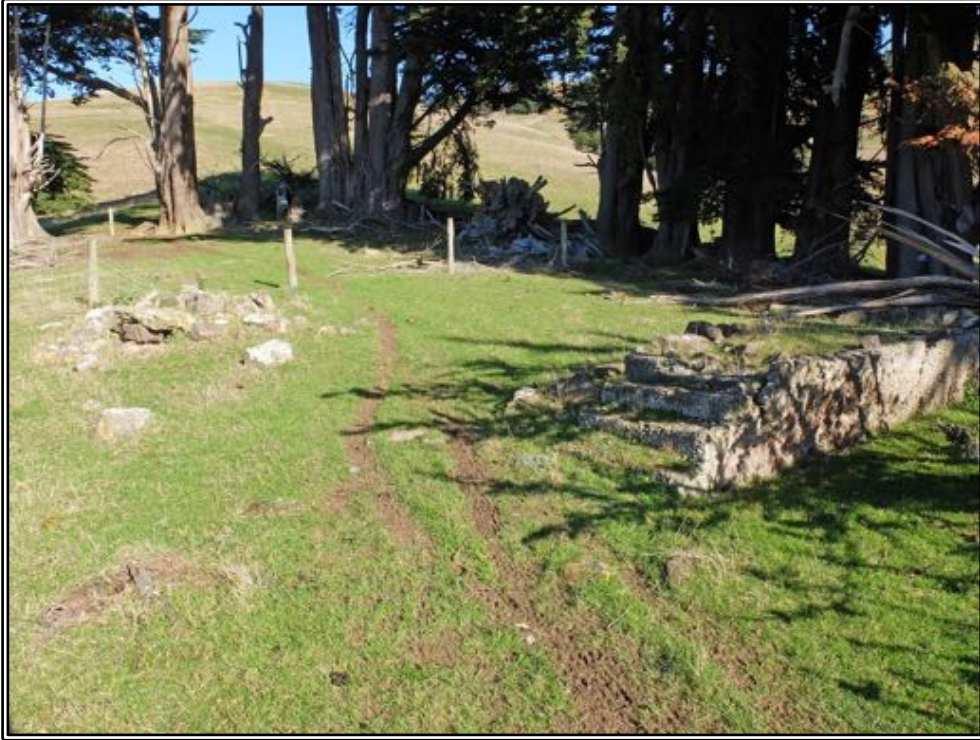
Figure 70
The site of Arnott's house (I44/420), with a stone foundation at left and steps at right.

- Condition: House site disturbed but intact features.
Stone wall in poor to moderate condition.
Byre site only, revetment in moderate condition.
- Threats: Stock on revetment. Tree branch fall.
- Tree management: Macrocarpas require maintenance (not urgent, but public regularly walk past site along marked track).

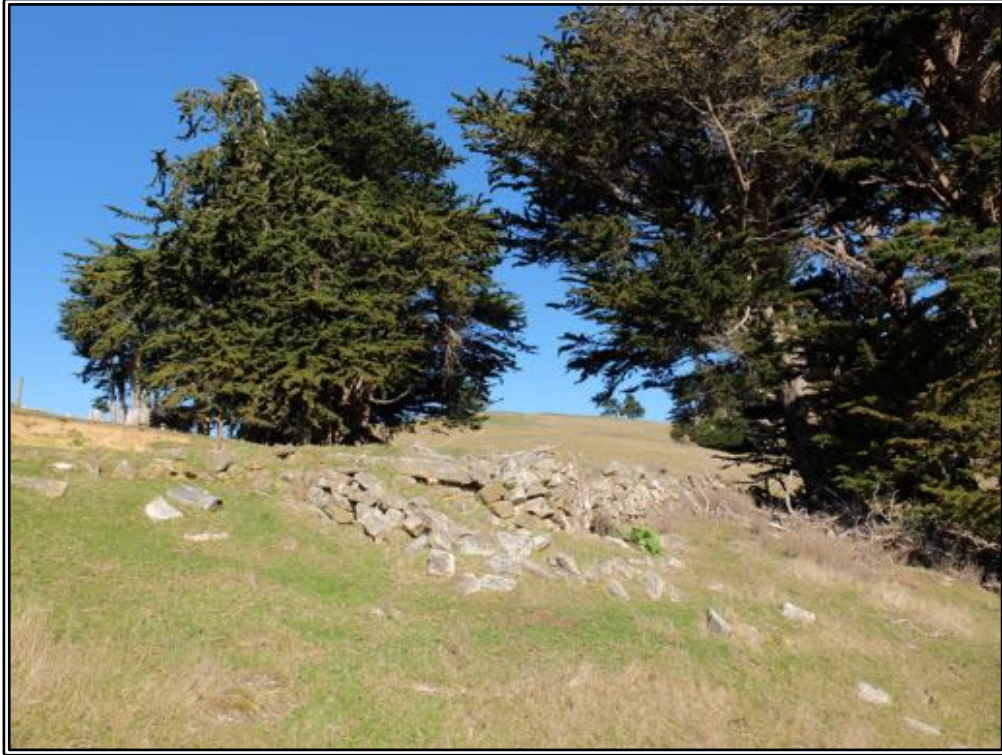
Figure 72

The stone revetment supporting the terrace of Arnott's byre (I44/420).

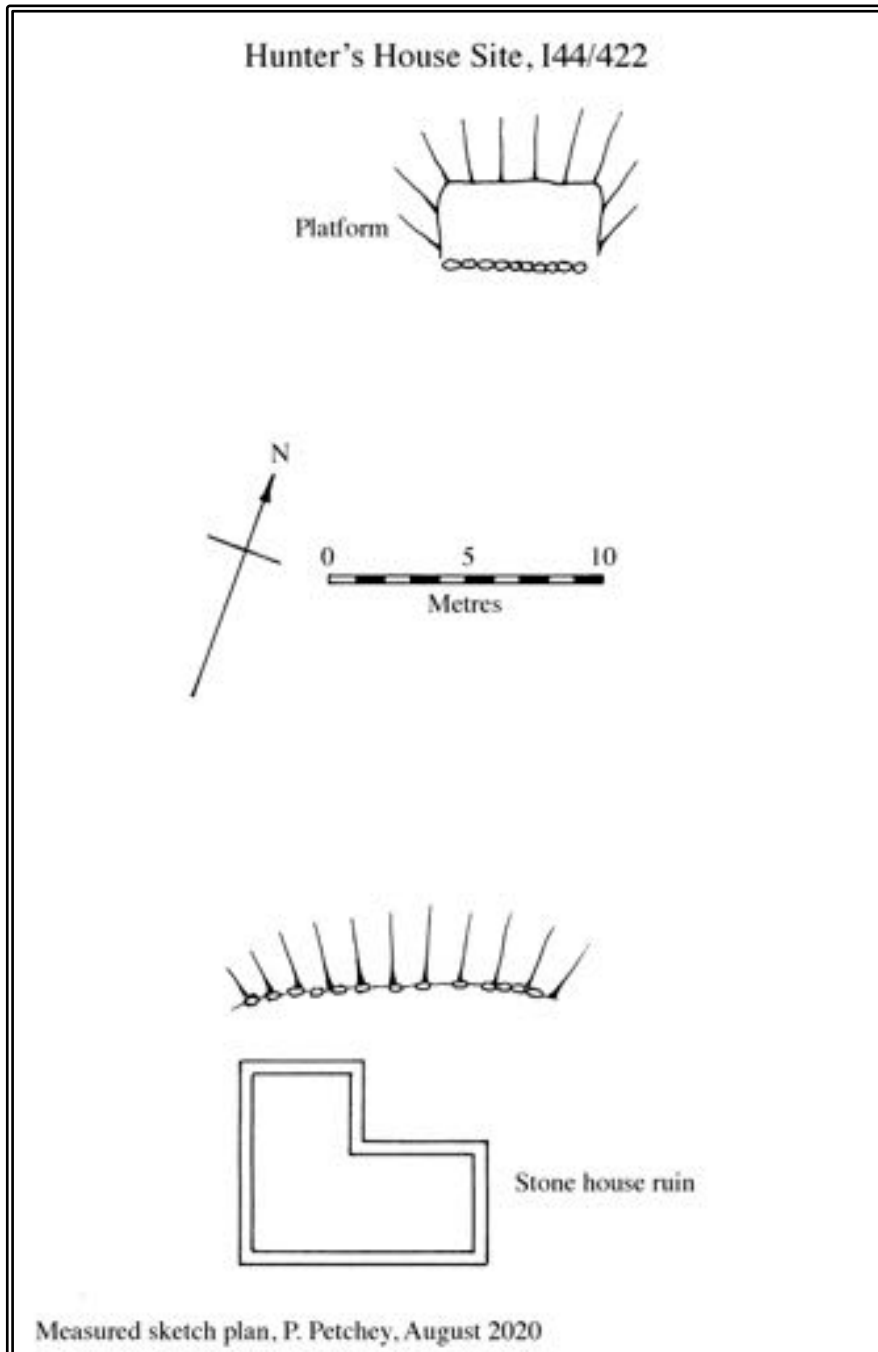
Figure 75
Plan of Hunter's house site, I44/422.

The ruins of Hunter's stone house are on a terrace cut onto the nose of a gentle ridge below the Highcliff Road. The structure was L-shaped, with maximum dimensions of 9m by 7.4m. The walls are 450mm (18 inches) thick, and stand to a maximum of 1m high. The stone appears relatively soft, and many of the blocks have been cut into regular shapes, and the walls appear to have been carefully built. Leslie noted in his handwritten manuscript (n.d.-a) that this house was of soft local stone, and had no trees around it, with little of it left standing at the time of writing. The lack of trees is supported by the archaeological evidence, as there are no stumps or other evidence of plantings around the house.

Condition: Stone ruin, standing to 1m.
Threats: Stock.
Tree management: N/A

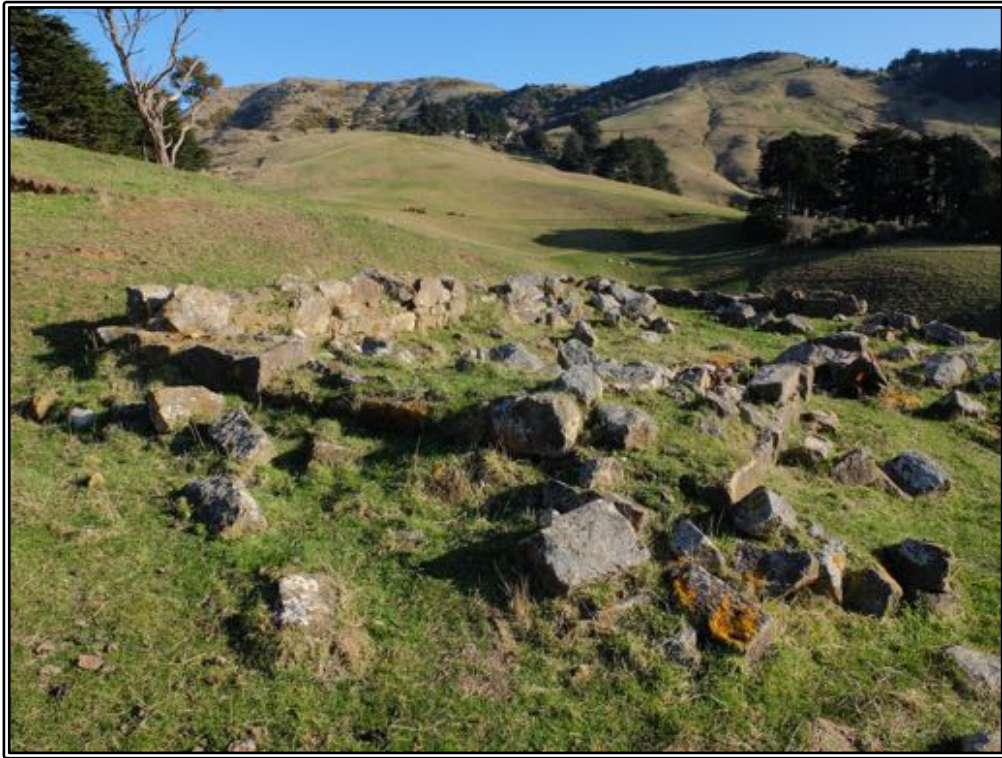
Figure 76
The ruin of Hunter's house, I44/422.

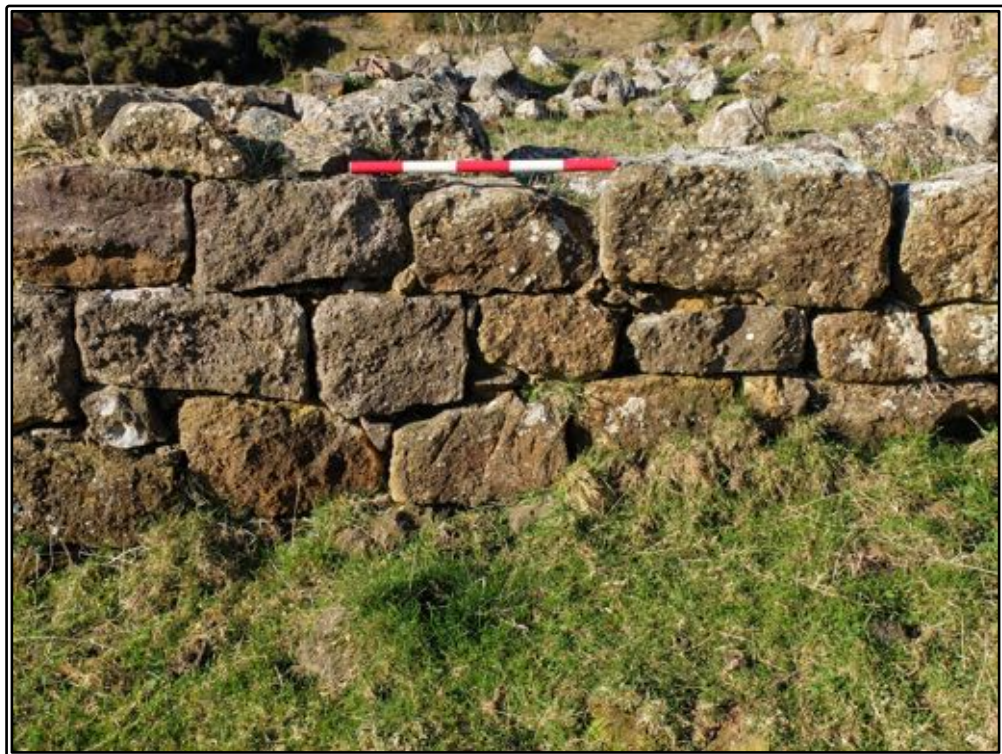
Figure 77
A detail of the west stone wall of the ruin of Hunter's house, I44/422.

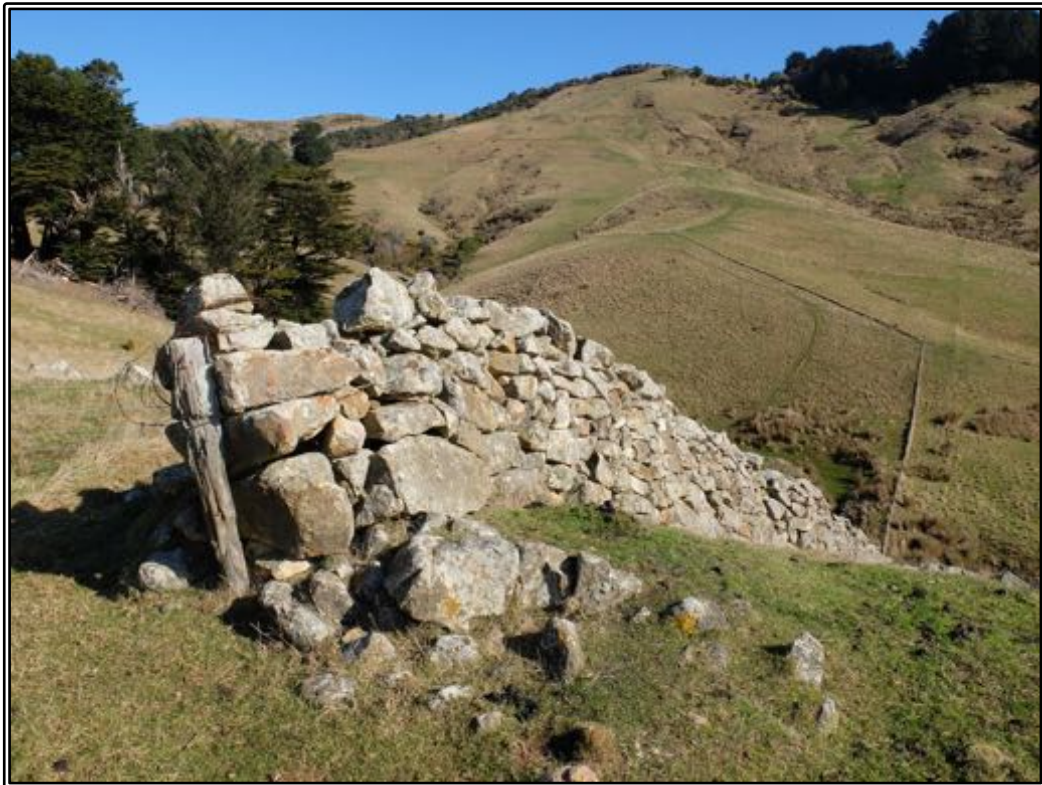
The stone wall is not continuous as several sections have been dismantled, and others possibly never built, and in these places conventional wire fencing has been used. The western (longest) extent is identified by Higham (1986) as Wall 4, while wall number 4A is located to the east below Highcliff Road. The condition of the wall varies from very good to very poor.

Condition: Variable from good to poor.
Threats: Heavy stock.
Tree management: N/A

Figure 80
Gate end in stone wall I44/102 (Higham wall 4). It is the same gate end shown in the previous image, and it can be seen how the wall is leaning slowly to the left (south).

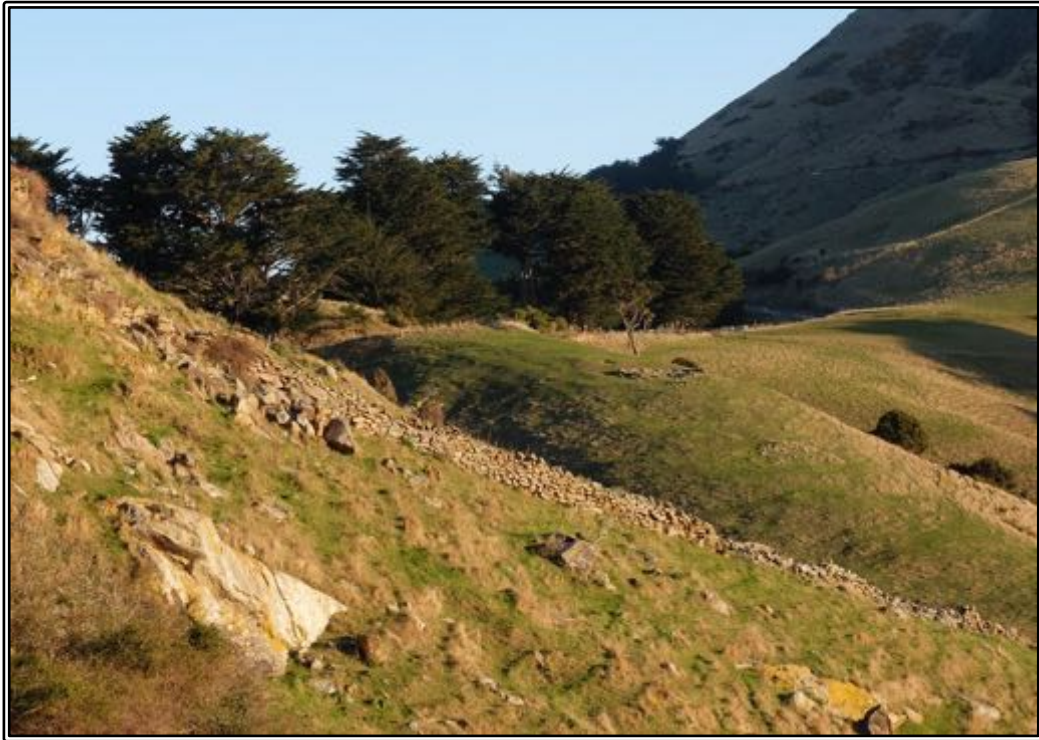
Figure 81

Stone wall I44/402, where it descends from Highcliff Road (Higham 1986 Wall 4A).

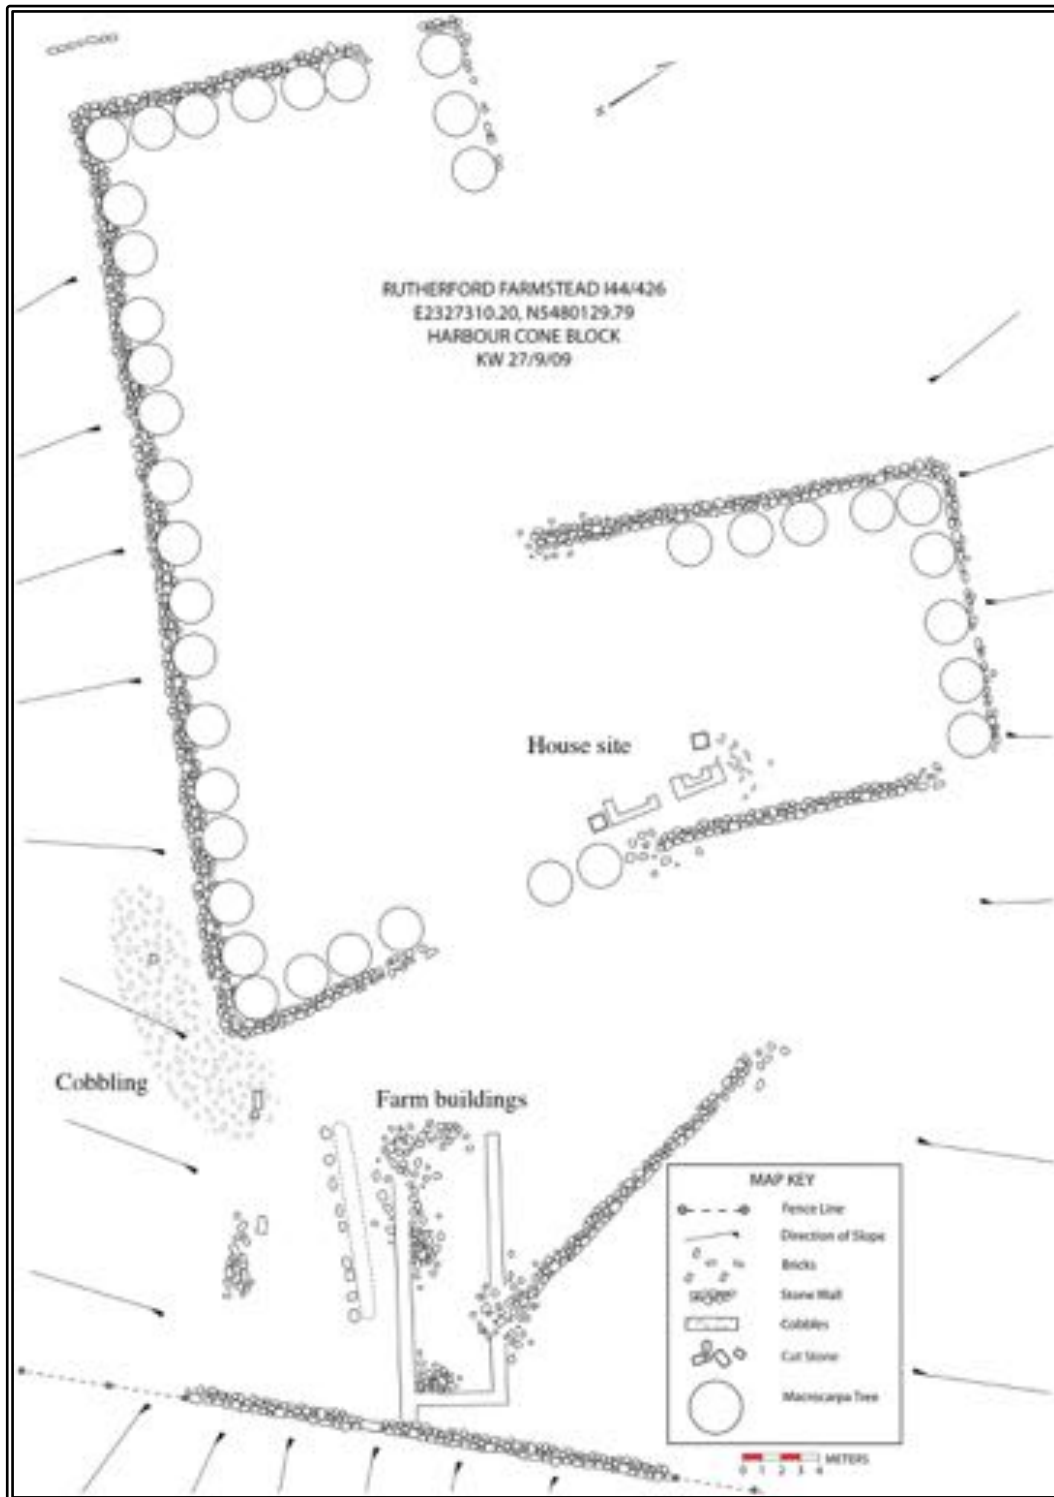
Figure 85
Plan of Rutherford's farmstead site (I44/426) (Plan by Kirsa Webb, with annotations).

Condition: Reasonable. All stone walls require stabilization, repair & maintenance. Trees healthy but require heavy pruning to remove dead wood.

Threats: Tree branch fall. Heavy stock.

Tree Maintenance: Pruning of macrocarpas (important).

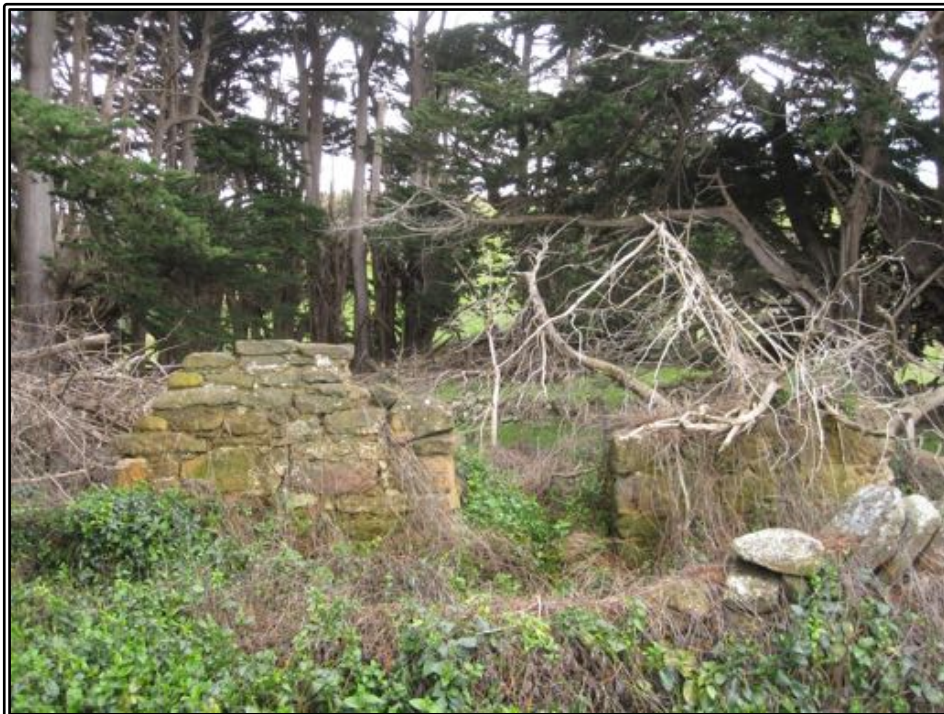
Figure 87
The ruin of Rutherford's house within the macrocarpa-enclosed farmstead site (I44/426).

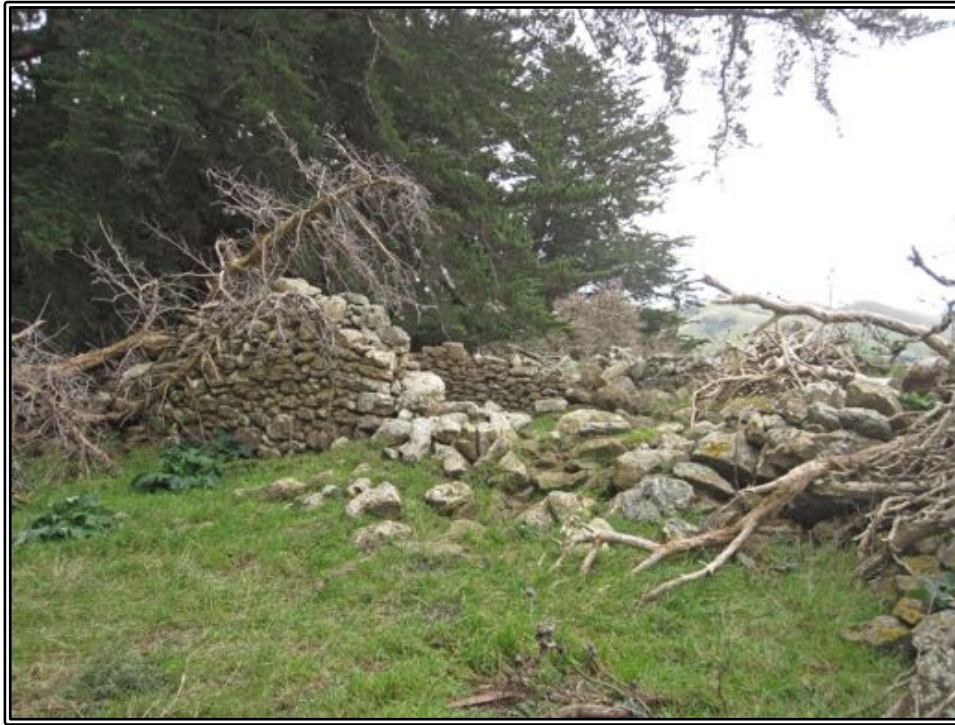
Figure 88
The ruins of the stone farm buildings, on the east side of the main macrocarpa enclosure at Rutherford's farm (I44/426).

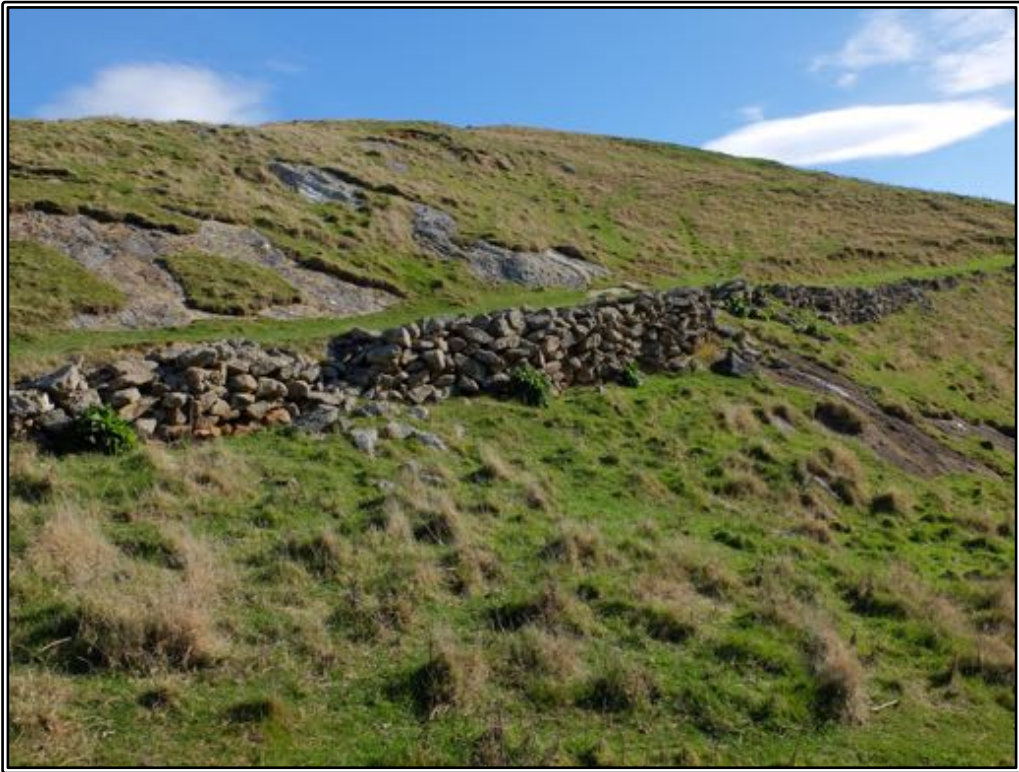
The road to Rutherford's farm and the Battery Creek gold mine turns off the Highcliff road in a rock cutting that is still in good condition, but is now fenced off. The road then zig-zags up the steep hillside (supported by areas of revetment, some of which has slumped). Near the top of the hill the main formation turns east (I44/424), and continues in a straight line towards the Battery Creek gold mine, along the boundary between Sections 3 of 36 and 41 (Nyhon's and Rutherford's properties). A short distance along this track, a fork goes off to the south east: this is Rutherford's Road (east) (I44/423). From the corner at the top of the zig-zag a third track branches off and also heads south east: this is Rutherford's Road (west) (I44/425). The two branches of Rutherford's Road meet and lead to Rutherford's farm. Stone walls are present beside the top of the gold mine road and Rutherford's Road west.

Figure 93
Stone revetment on Rutherford's Road east (I44/423)

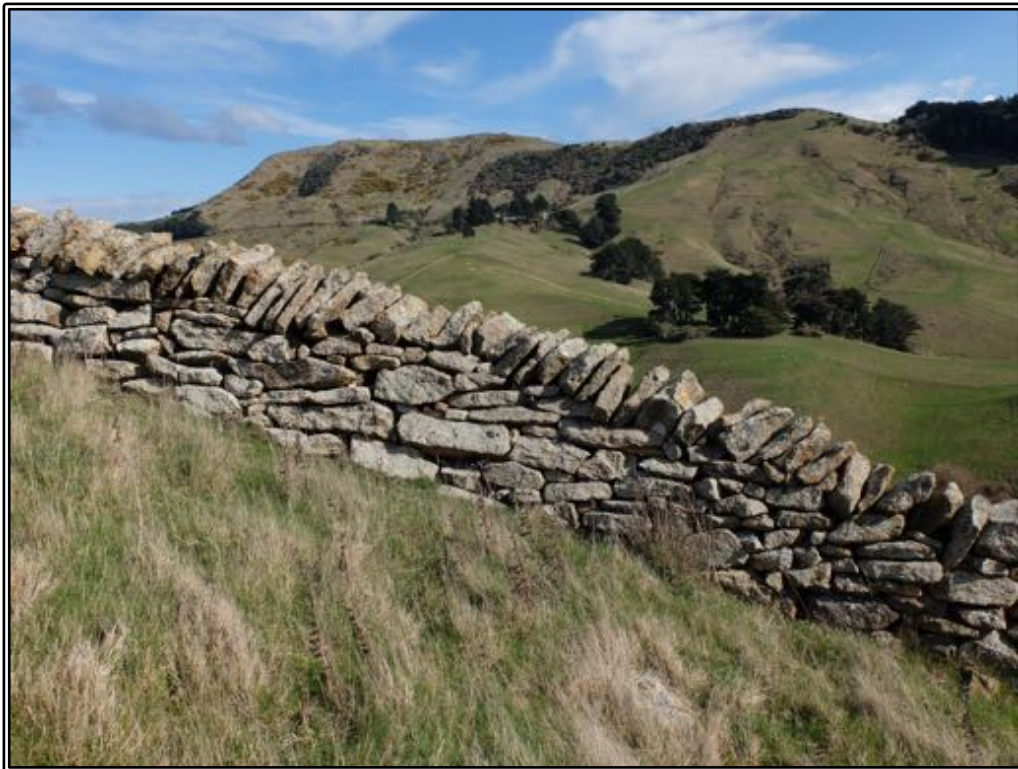
Condition: Mixed: very good to poor.
Threats: Heavy stock.
Tree maintenance: N/A

Figure 99
A well preserved section of wall I44/1018 (Higham wall 3) beside Rutherford Road west.

One of the marked walking routes on the Harbour Cone block runs along the adjacent roadline so the wall is highly visible to visitors. The combination of high quality construction, spectacular setting on the high ridge of the Peninsula, and high public visibility, make this wall a priority for potential stabilization and maintenance work.

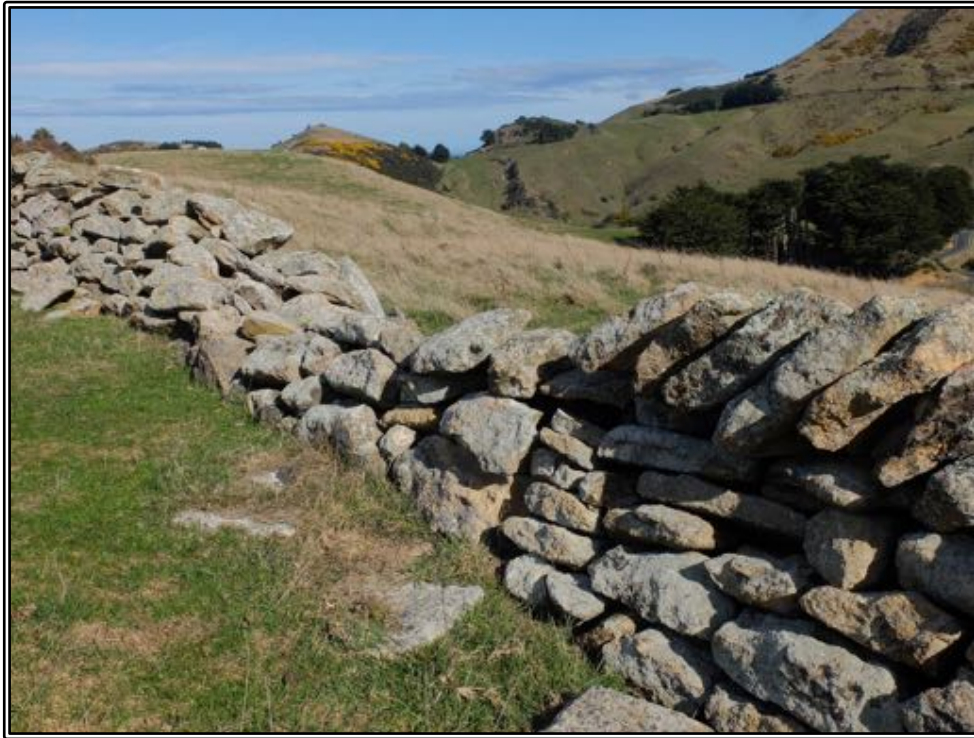
Figure 100

This stone wall runs beside the west branch of Rutherford's Road (I44/425). It runs across the flat top of the hill, and is one of the most impressive stone walls on the Harbour Cone block (rivalled only by the northern boundary wall I44/410). It is a well-made drystone wall with neatly-laid capping stones. Some of the wall is in almost perfect condition, but a some length has partially collapsed. It was recorded by Higham (1986) as Wall 3.

Stone wall I44/1018 (Higham wall 3), slightly to the east of the image above, showing a section where the wall has partially collapsed.
