HEREWEKA HARBOUR CONE

CONSERVATION PLAN
2020
PETER PETCHEY & JILL HAMEL

HEREWEKA HARBOUR CONE
OTAGO PENINSULA
CONSERVATION PLAN
2020

PETER PETCHEY
SOUTHERN ARCHÆOLOGY LTD.

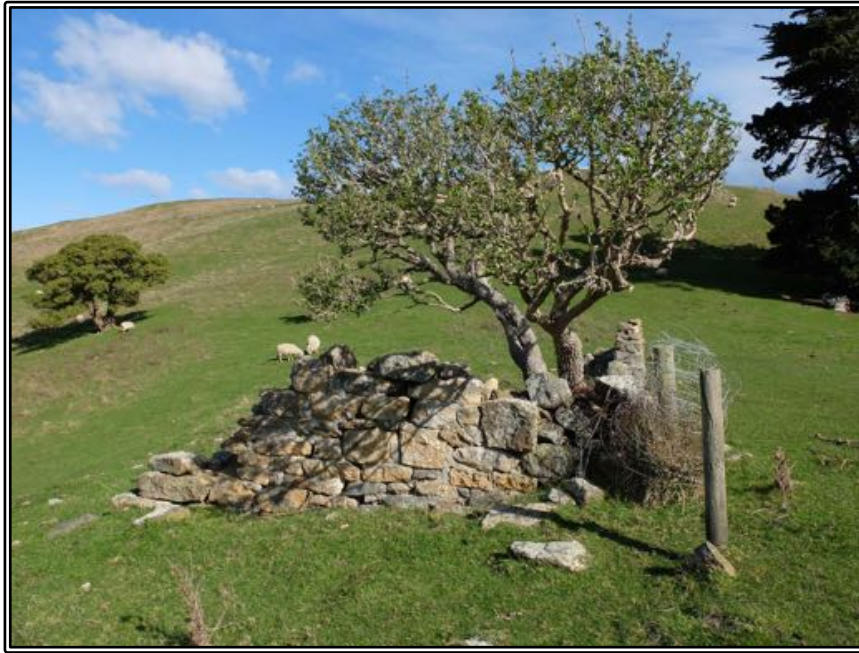
Condition:	Ruinous.
Threats:	Heavy stock
Tree management:	N/A

Figure 103
The ruin of Nyhon's cow byre (I44/429).

The byre should be stabilized and maintained by a qualified mason to prevent further deterioration.

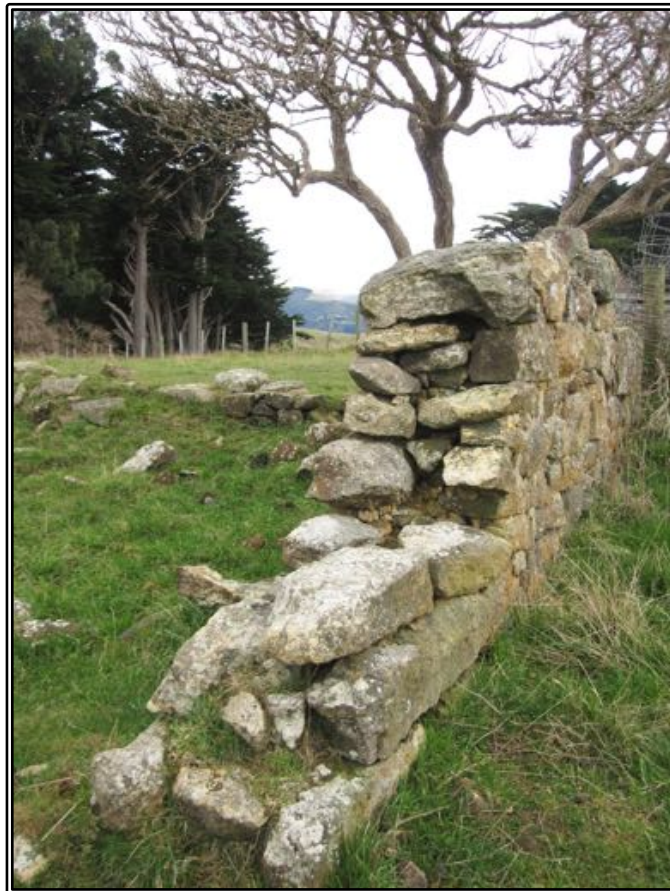
Figure 104
Detail view of the end wall of Nyhon's byre (I44/429), showing how the wall was constructed.

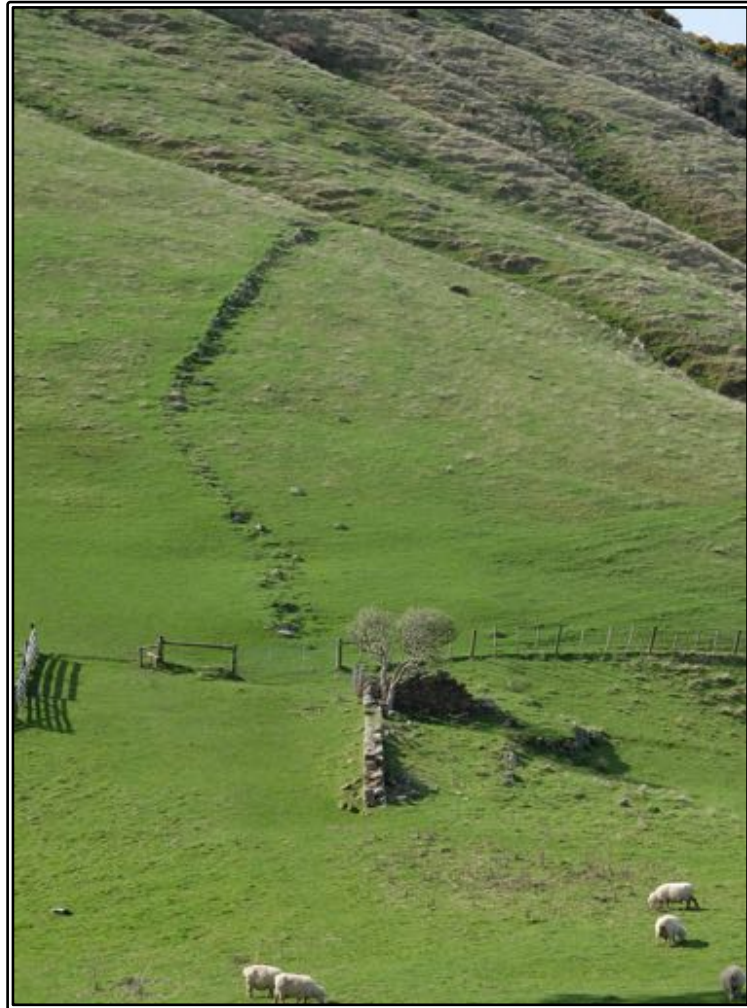
Figure 105

A stone wall in poor condition runs up the flank of Harbour Cone from beside Nyhon's cowbyre (I44/429) up towards Leslie's road (I44/432). The wall was identified in Higham (1986) as wall 10. It was probably built by the landowner John Nyhon.

Stone wall I44/433, with the ruin of Nyhon's byre (I44/429) at its lower end.

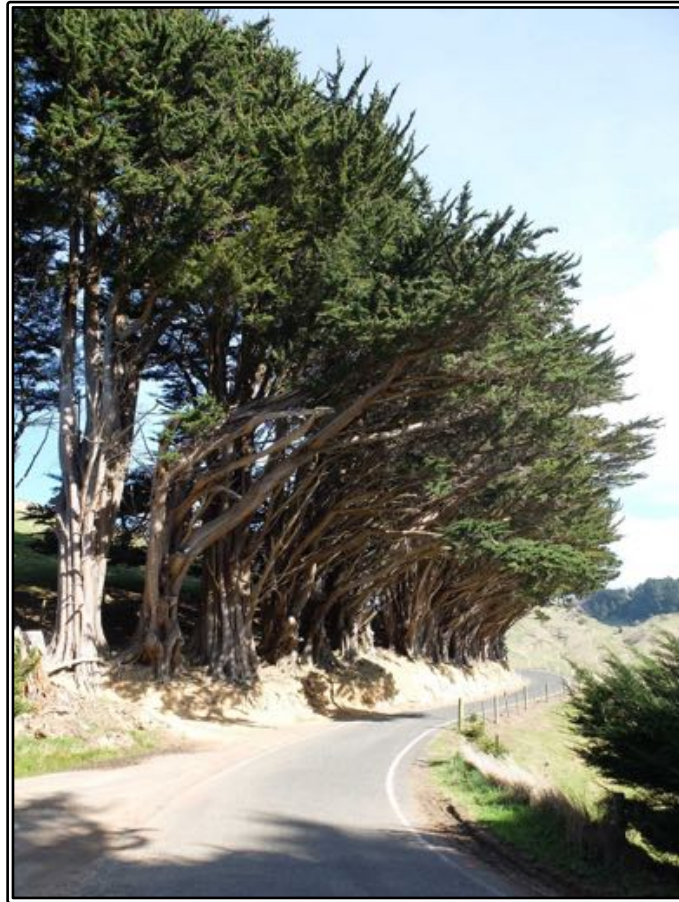
This site consists of the stand of macrocarpas along the boundary of Highcliff Road at either side of Nyhon's gateway. Neill included some of these trees in his 1901 map. These stands of macrocarpas are two of many that form part of the relic landscape of Harbour Cone. They appear to be healthy, but will require future maintenance to remove dead wood.

Figure 106
The stand of macrocarpa trees (I44/444) beside Highcliff Road next to Nyhon's farmstead site (I44/428).

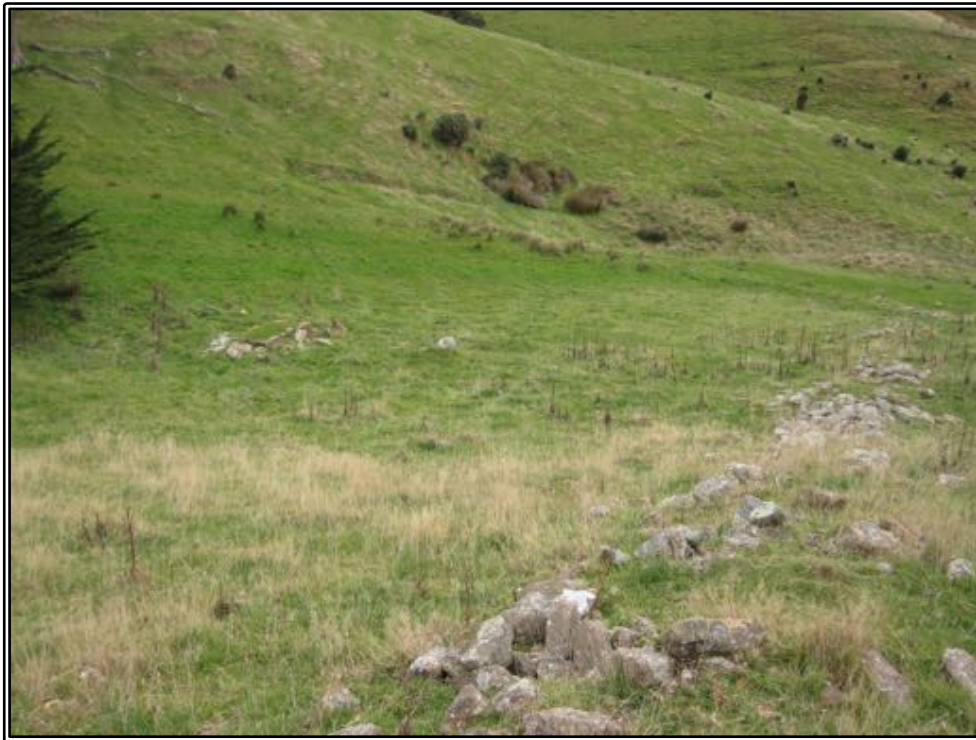
Figure 107

The site of Robert Dick's farmstead is in the valley to the south of Nyhon's byre, and is marked by a single large macrocarpa. The house site consists of the masonry base of a fireplace and some steps. A collapsed/robbed stone wall (Higham wall 9) partially surrounds the house site.

Dick's farmstead site (I44/431), with the farmstead wall in the foreground (Higham wall 9) and the chimney base of the house left of centre.

Condition: House site: chimney base + subsurface.
Wall: poor.

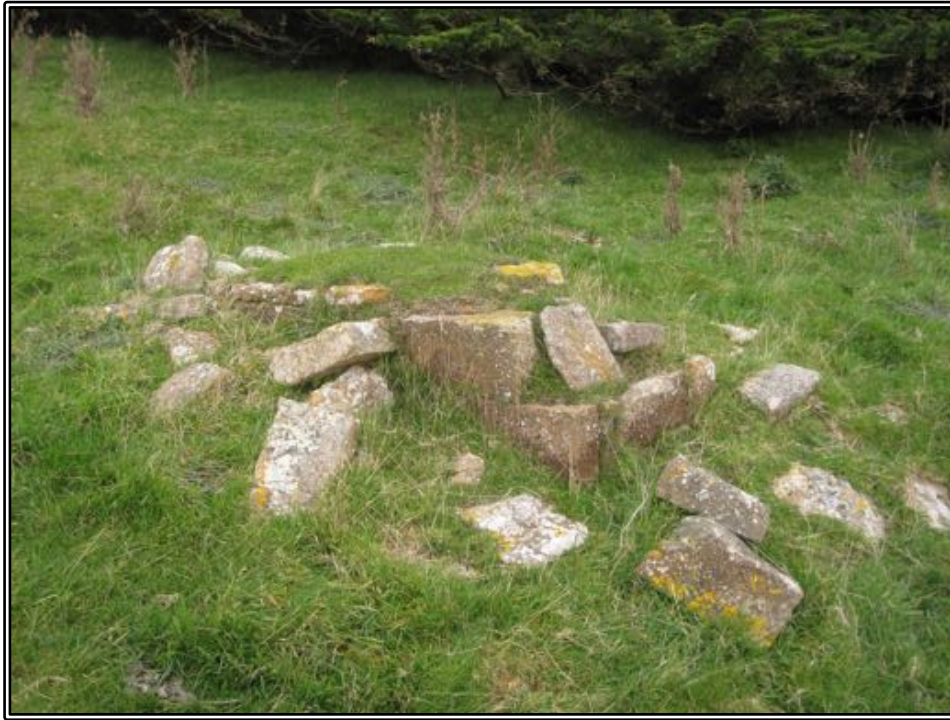
Figure 108
The masonry chimney base at Dick's farmstead (I44/431).

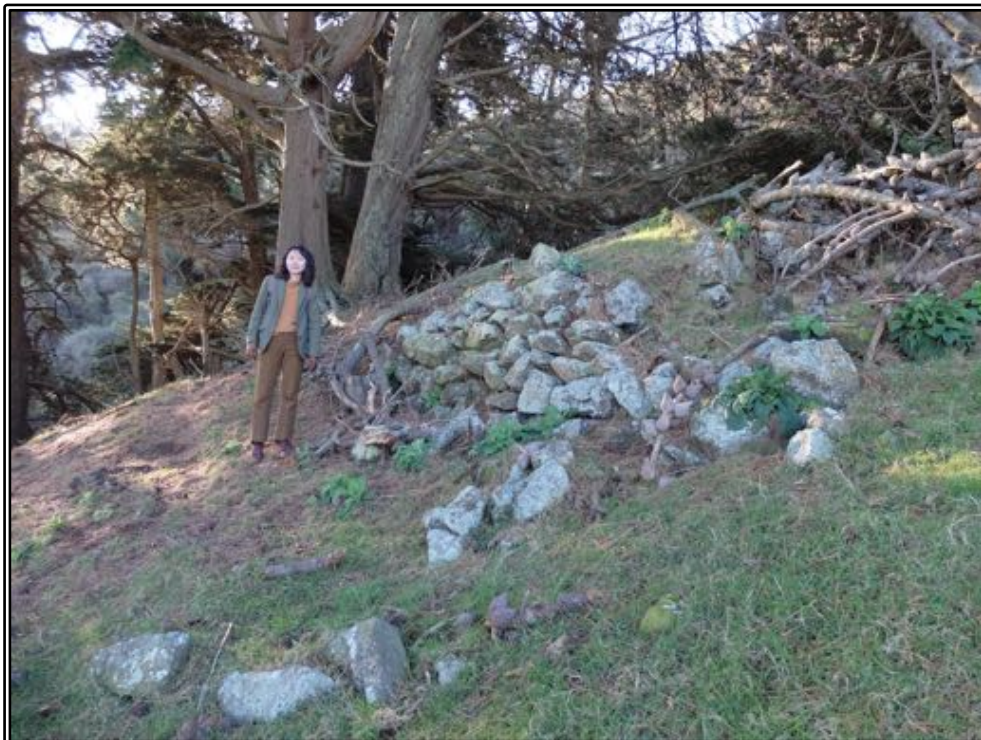
Figure 113
Stone revetment below the main terrace at Leslie's farm site (I44/82).

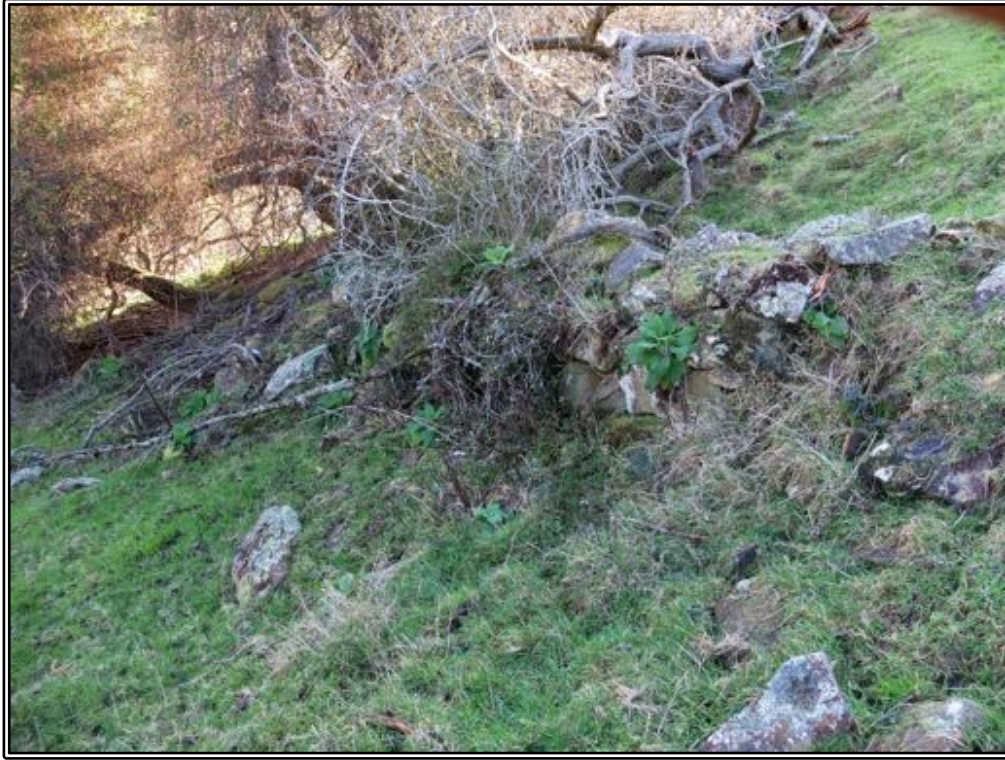
A series of terraces are located on the downhill side of Highcliff Road at this site. The uppermost terrace (only just below road level) was probably the location of the Peninsula County Council road metal crushing plant, and may also have been where the cheese factory stood. An access track off the road is still visible (although now fenced across). Below this is a larger terrace (approximately 20m by 8m) bounded by several large old pine trees, and with several areas of stone revetment below. This was probably the main house site, although there is not surface evidence of the house structure. Further down the hill there is a very rough stone wall and overgrown hawthorn hedge line. The wall is approximately 10m long.

Figure 114
Rough stone wall below Leslie's farmstead site (I44/82).

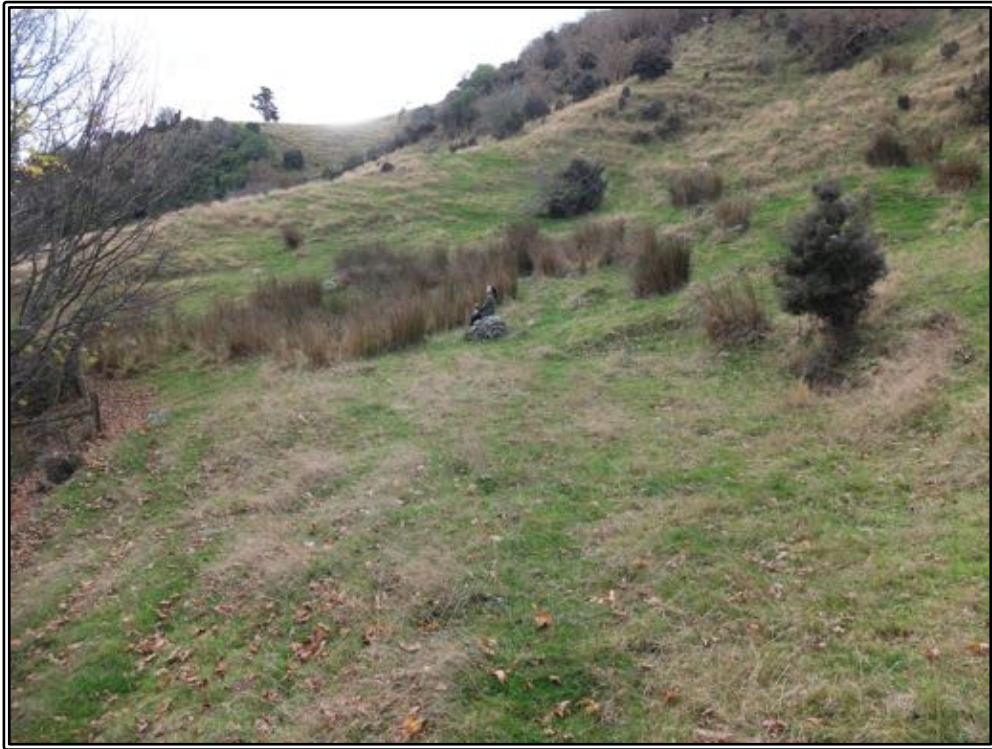
Condition:	Site only. Possibly sub-surface archaeological evidence.
Threats:	None anticipated.
Tree management:	N/A

Figure 115
The terrace on the upper side of Highcliff Road that was probably the site of Leslie's cowshed (I44/437).

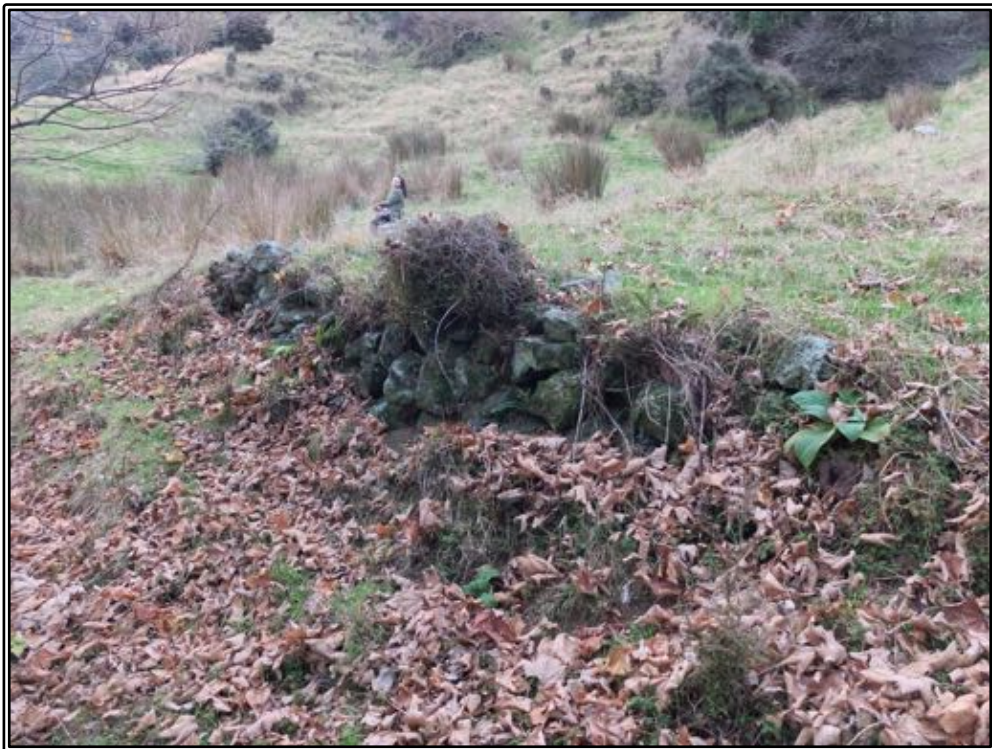
Figure 116
Stone revetment at Leslie's cowshed terrace I44/437.

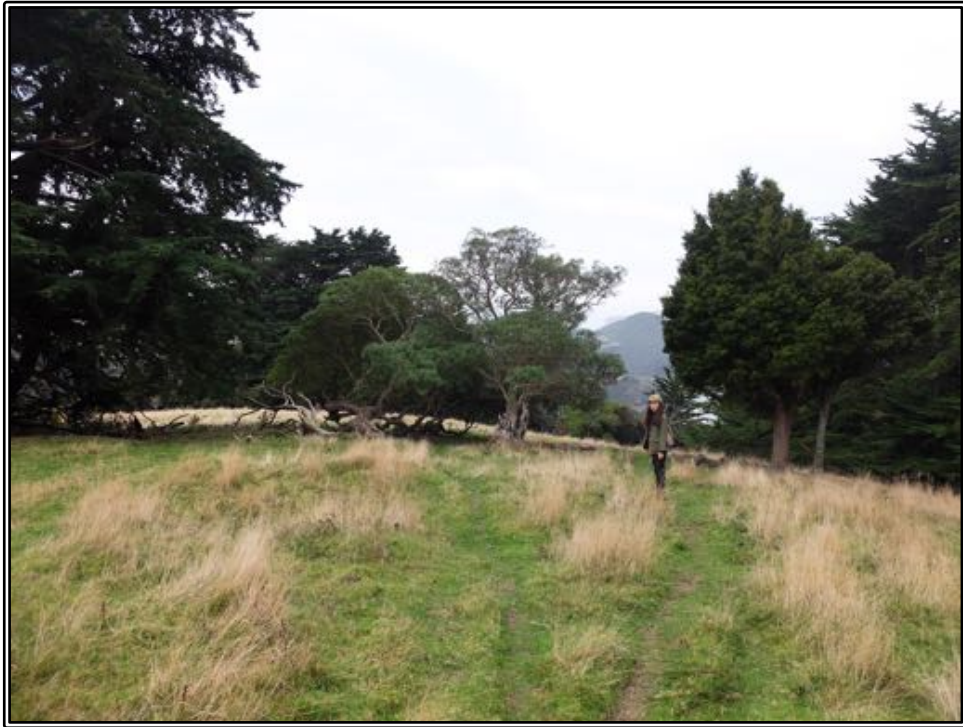
Condition:	Good. Surface features and sub-surface evidence. Trees good.
Threats:	None anticipated.
Tree management:	Tree maintenance (non-urgent). Pruning branches overhanging historic features.

Figure 118
The house site at Leslie's farmstead (I44/445), with exotic trees planted across far side of terrace.

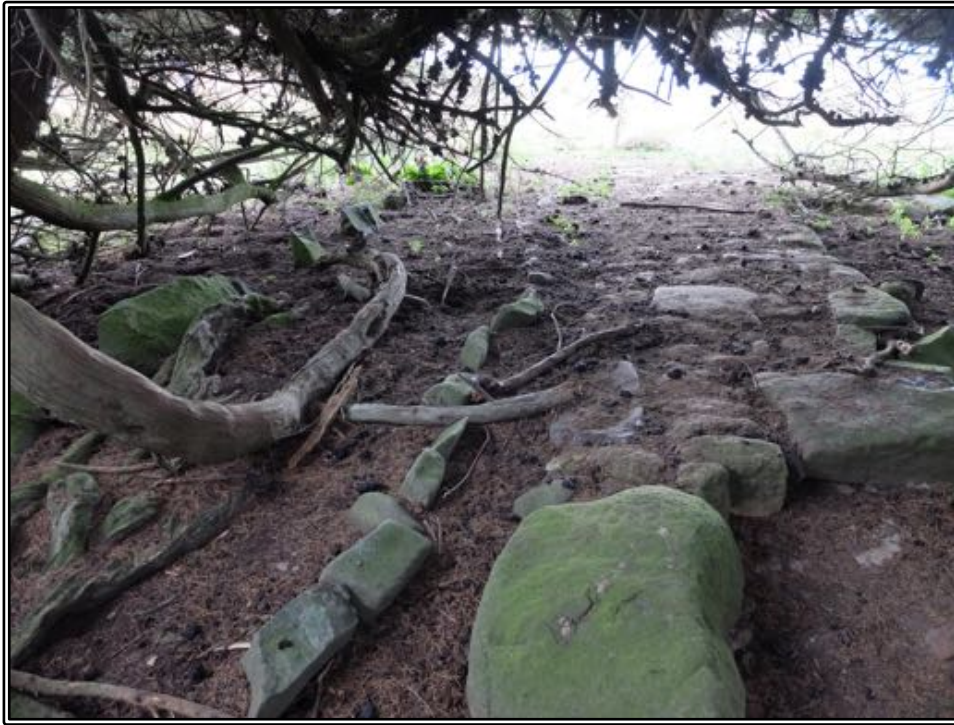
While the farmstead area remains open and in grass, it is evident that scrub is slowly encroaching on the area, especially along the eastern end of the access track. The macrocarpa trees are far enough away not to pose a threat to the site, although the one overhanging the stone paving could be trimmed to allow the paving to be seen more easily.

Figure 120
Stone paving and edging at Leslie's farmstead (I44/445), underneath a large macrocaroa tree. This was probably related to the dairy or one of the outbuildings.

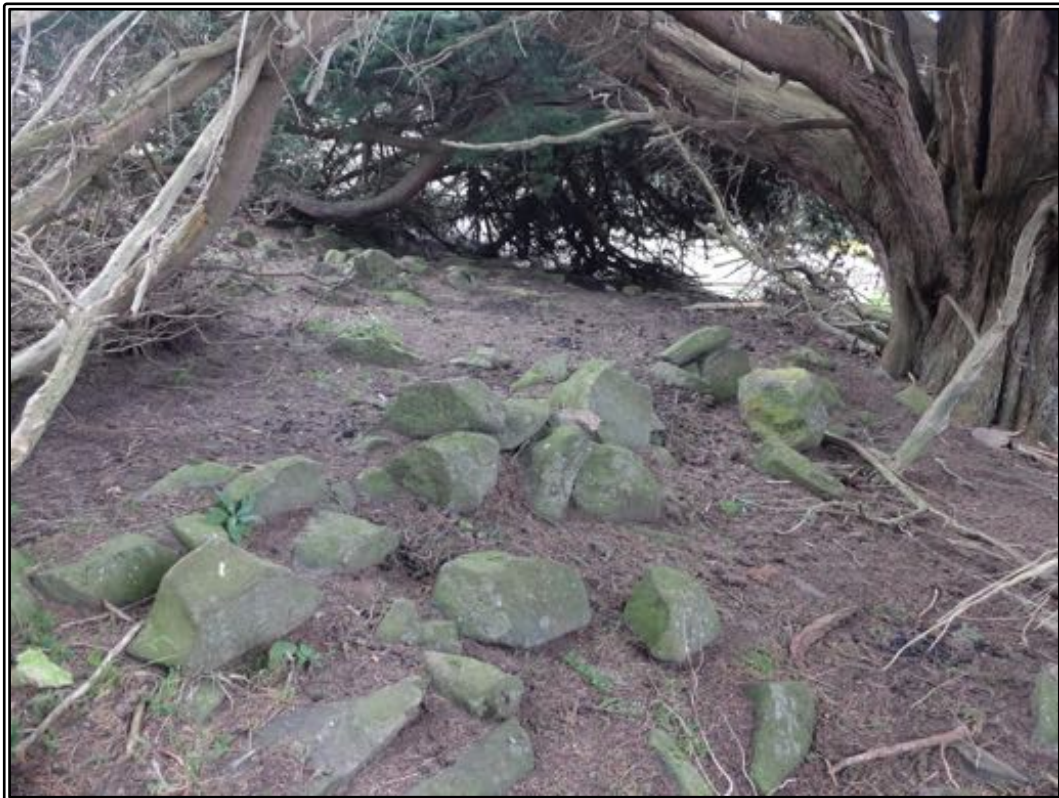
This a short stone wall and row of macrocarpas within Section 47, which belonged to Captain Leslie. It probably relates to an area around the homestead of William Leslie (junior) (I44/445) that is shown on Neill's 1901 map. Higham (1986) recorded it as wall14. The wall is in poor condition, both as a result of the trees blowing it apart and stock sheltering under the trees. The wall is not particularly visible, and does not appear to receive many visitors.

Condition: Poor
Threats: Stock, trees.
Tree management: Tree maintenance (non-urgent).

Figure 123
Higham wall 14, under macrocarpa trees.

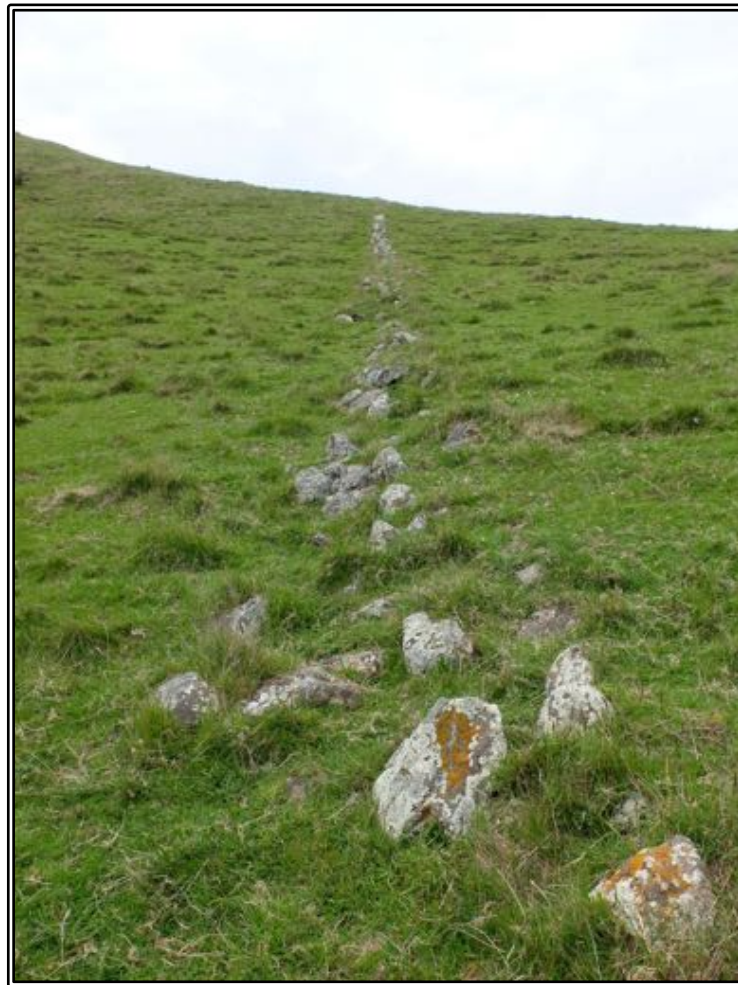
This stone wall in poor condition runs along the boundary between Leslie's section 47 and Nyhon's section 45, probably built between the date of Nyhon's Crown Grant in 1860 and 1877, the same dates being likely for wall 10. It is identified as wall 11 in Higham (1986: 114). It is possible that it was a field clearance line, and that it was never a full-height stone wall, and that instead a fenceline ran long the alignment.

Condition: Poor
Threats: Heavy stock.
Tree management: N/A

Figure 124
Looking along the line of stone wall I44/434 (Higham wall 11) on the boundary between Nyhon's and Leslie's properties.

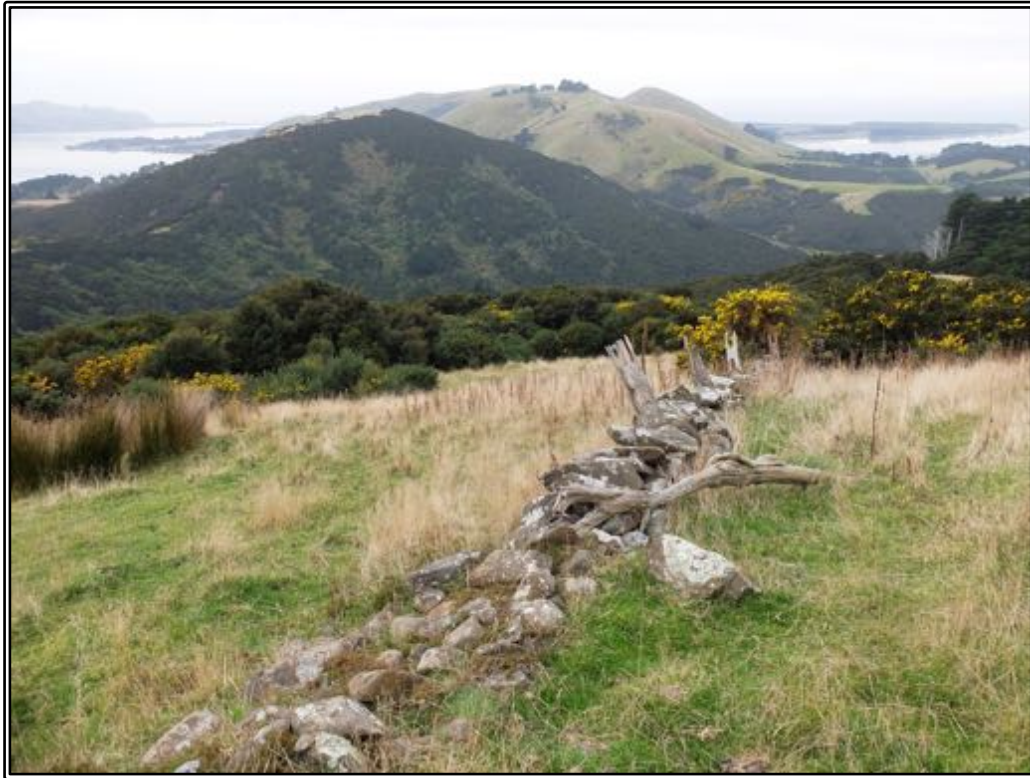
Figure 130

Comparison of 1986 with 2020 photographs show that the eastern section (Higham wall 13) has deteriorated, probably due to stock action on the stonework.

The eastern end of stone wall I44/436 (Higham wall 13) in 2020. Some deterioration can be seen in the stonework since 1986, probably due to stock, and the encroachment of gorse and scrub is obvious.

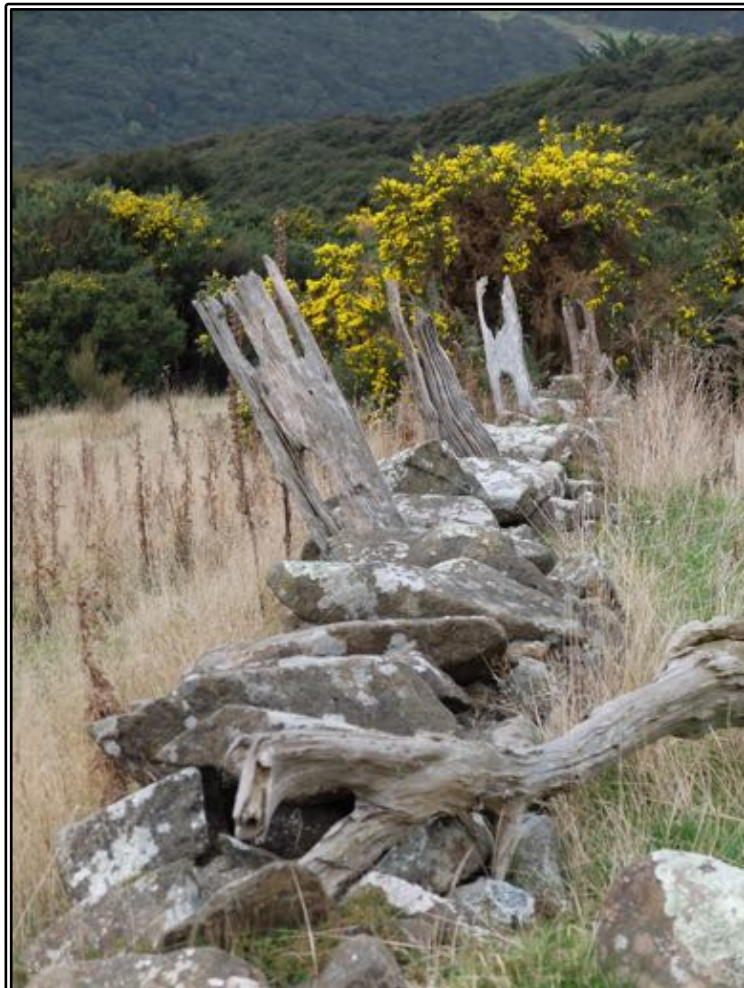
Figure 131

Fenceposts in the eastern end of stone wall I44/436 (Higham wall 13) in 2020. The augered holes for rails are still obvious: this would originally have been a low stone wall with a post and rail fence on top. This wall appears to comply with the 1855 *Otago Provincial Council Fencing Ordinance of 1855* that required a minimum wall height, which could be achieved by a low wall being surmounted by a paling or wire fence.

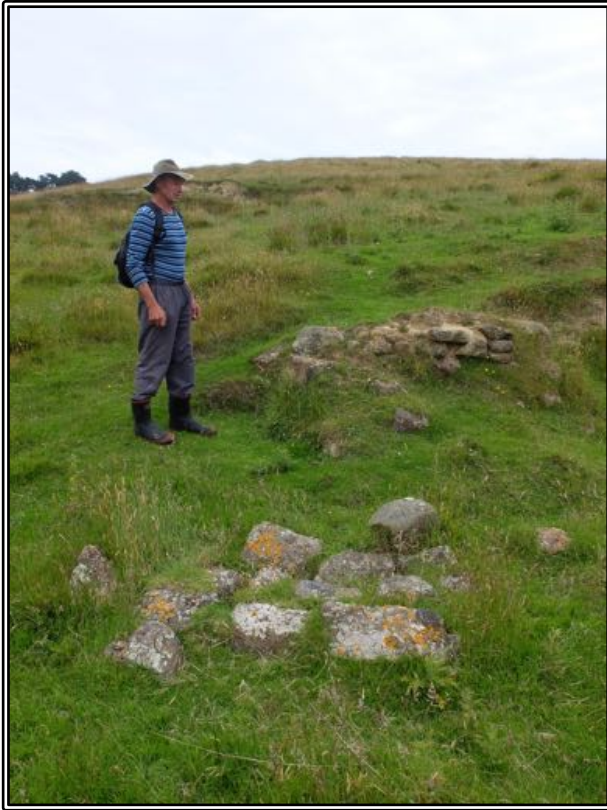
The site consists of two terraces cut into the hillside. The lower terrace measures 8.5m by 8m, and has two stone fireplace bases and fallen stonework (probably from one of the chimneys). The farmhouse would have stood here. The upper terrace, 20 metres up the hill, measures 13m by 5m, and has no surface evidence of structures. Several split timbers are scattered on the hillside between the terraces. Some soil erosion due to stock trampling is evident.

Condition:	Ruins only, sub-surface archaeological evidence present.
Threats:	Heavy stock causing erosion.
Tree management:	N/A

Figure 135
Alf Webb standing beside the remains of
one of the two stone fireplaces at
farmstead site I44/982.

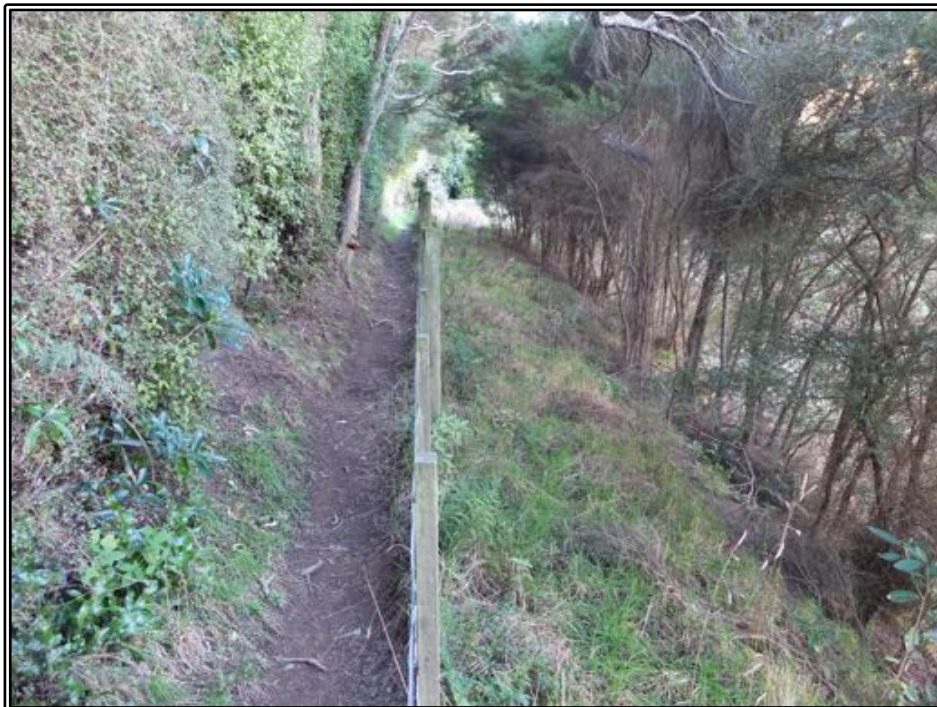
Figure 137
The lower section of Bacon's Track (I44/442), where a modern fenceline has been placed down the middle of the old bridge track formation.

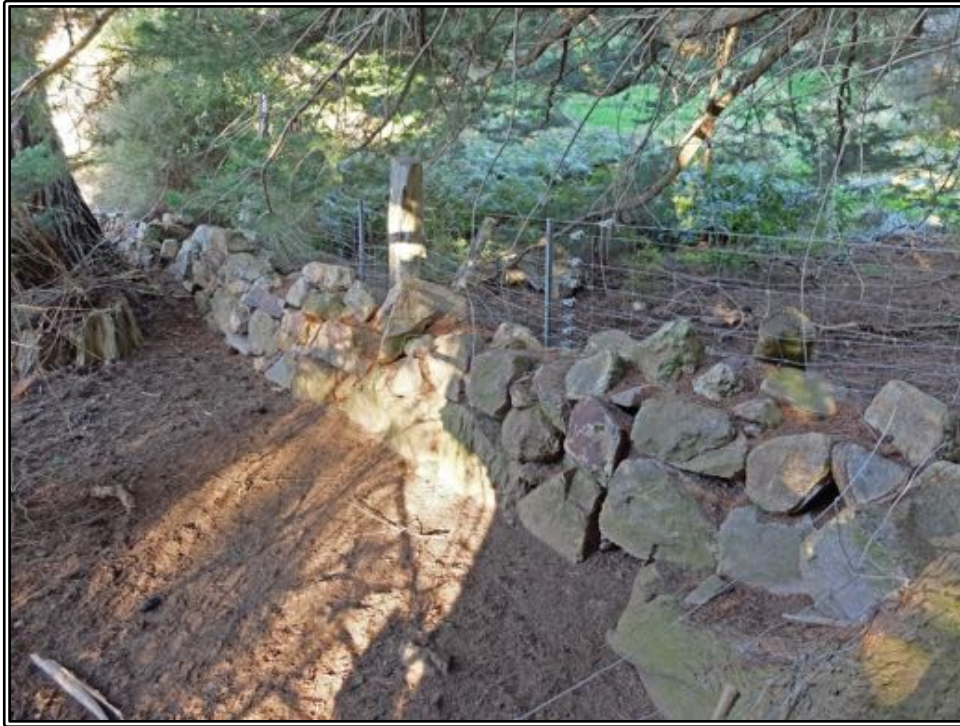
This wall was recorded by Higham (1986) as Wall 20. It runs at right angles near the end of the Bacon track, marking the boundary between what was once section 21 and section 13. It must have been built prior to 1872, when both sections became part of the Camp Estate. It is built from large blocks of stone, and is in reasonable condition.

Figure 138
Stone wall I44/452 (Higham wall 20), at the northern extent of the Harbour Cone Block.

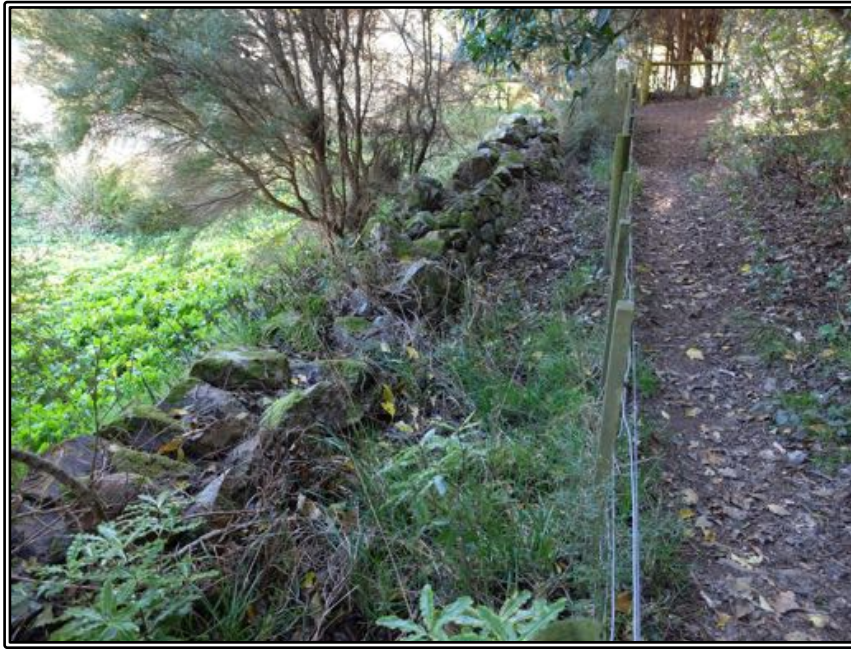
This stone wall runs beside Bacon's Track where the track curved out towards the west to go around the foot of a spur. The stone may have come from a small quarry on the other side of the track (I44/1016). Higham (1986) recorded it as Wall 19, and observed that it was made from shaped blocks, and is not typical of walls built along the Larnach estate boundaries. She thought it probably the work of Bacon and his employees. The wall is in poor to moderate condition.

Figure 139
Stone wall I44/1015 running beside part of the lower section of Bacon's Track (I44/442)
(Higham wall 19).

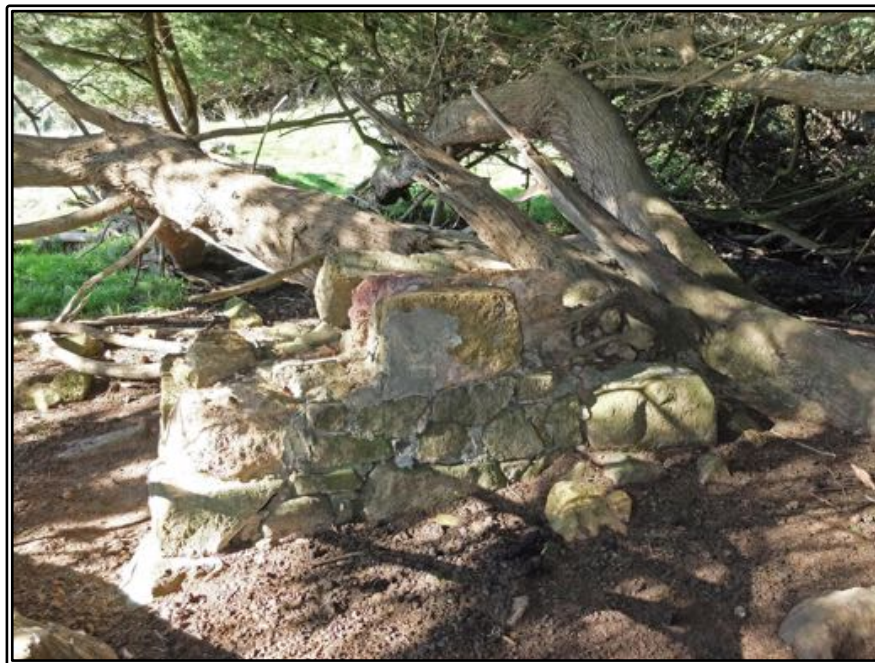
Figure 151

The stone fireplace base of Ward's house beneath the trees of the farmstead site (I44/441). The other end of the house terrace has been modified with a pond.

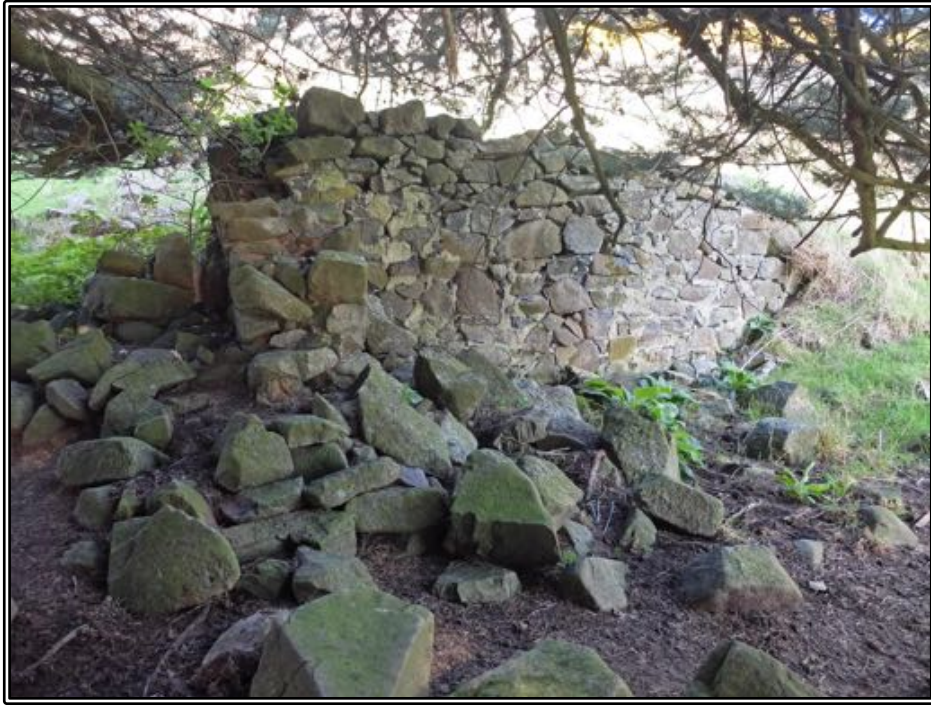
Figure 152

Condition:	Archaeological features disturbed, but present. Stone walls moderate to poor.
Threats:	Tree branch falls.
Tree management:	Trees healthy, but require extensive maintenance.

The ruins of Ward's cow byre at Ward's farmstead site (I44/441). Harwicke Knight photographed these ruins in the 1960s (see image above).

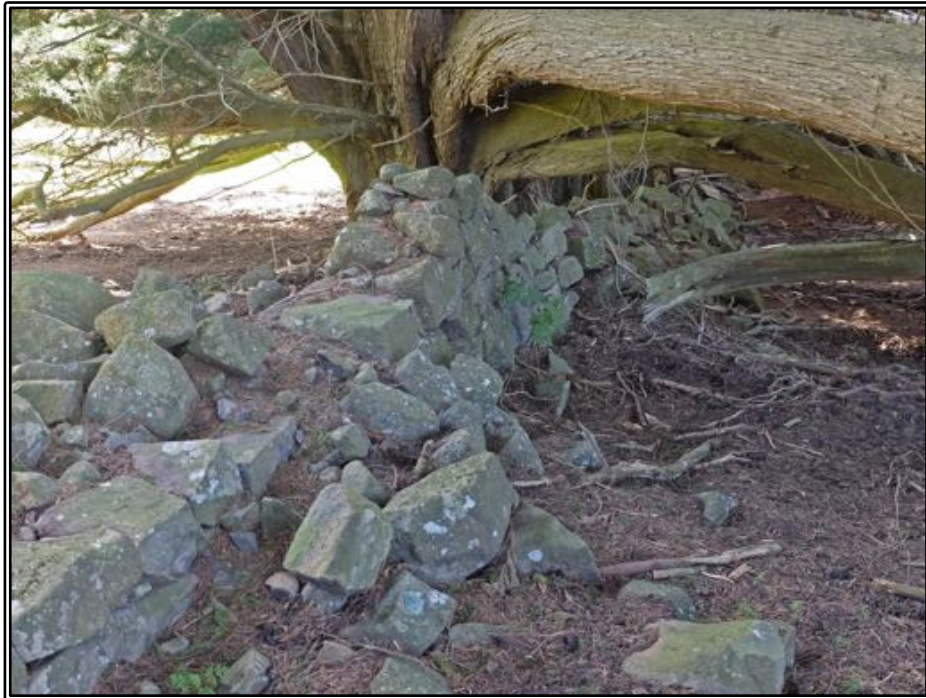
Figure 153

Stone wall running under macrocarpa trees at Ward's farmstead (I44/441). This wall was recorded as Higham wall 1.

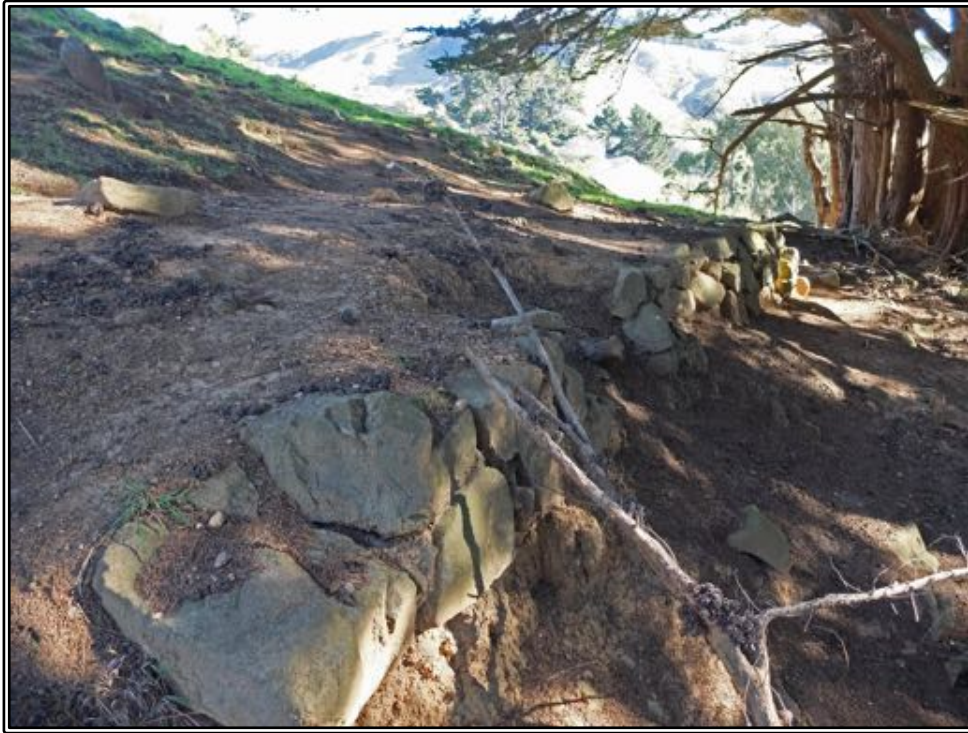
Figure 154

This is the access track that led from Highcliff Road to Ward's farmstead. The track crossed an unstable section of hillside, and at least half of its length has been destroyed. The best preserved section is where the track enters the area within the farmstead macrocarpas. Here the track is well-benched and revetted with very large stones. However, the track is generally in poor condition, with many areas eroded away. This is probably due to a combination of the steep slope and stock movement.

Stone revetment along Ward's Road (I44/450), where it runs beneath the large macrocarpas around the farmstead site (I44/441). Note the large size of the stone blocks.

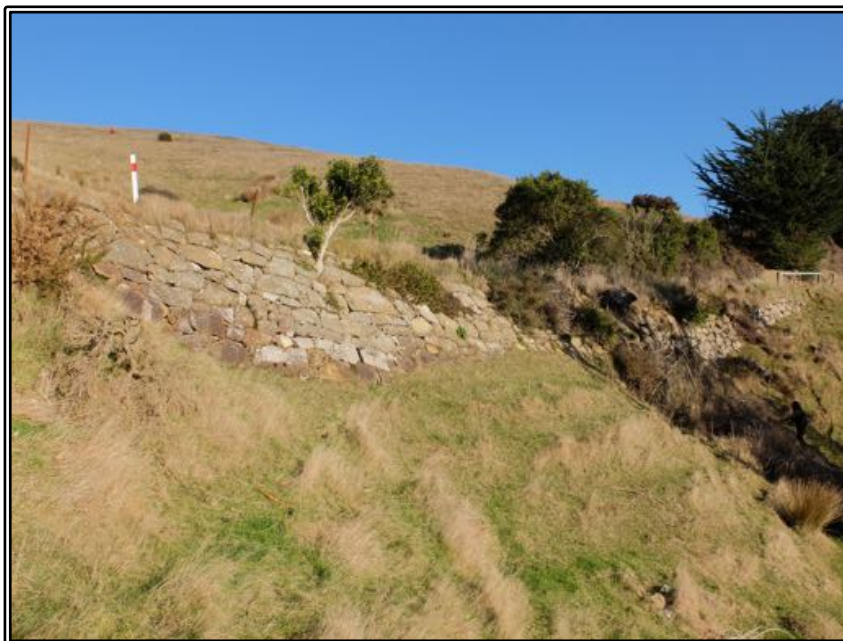
A substantial and well-built stone revetment below Highcliff Road. The stonework extends approximately 30 metres, is battered back, and stands to a maximum of about 3.2 metres. A small flow of water runs through the middle of the wall and down the gully below. A tree had been growing out of the middle of the revetment: this had been cut down, but the roots have displaced some of the revetment and it may need repair at some time.

Figure 155
Stone revetment below Highcliff Road (I44/1014).

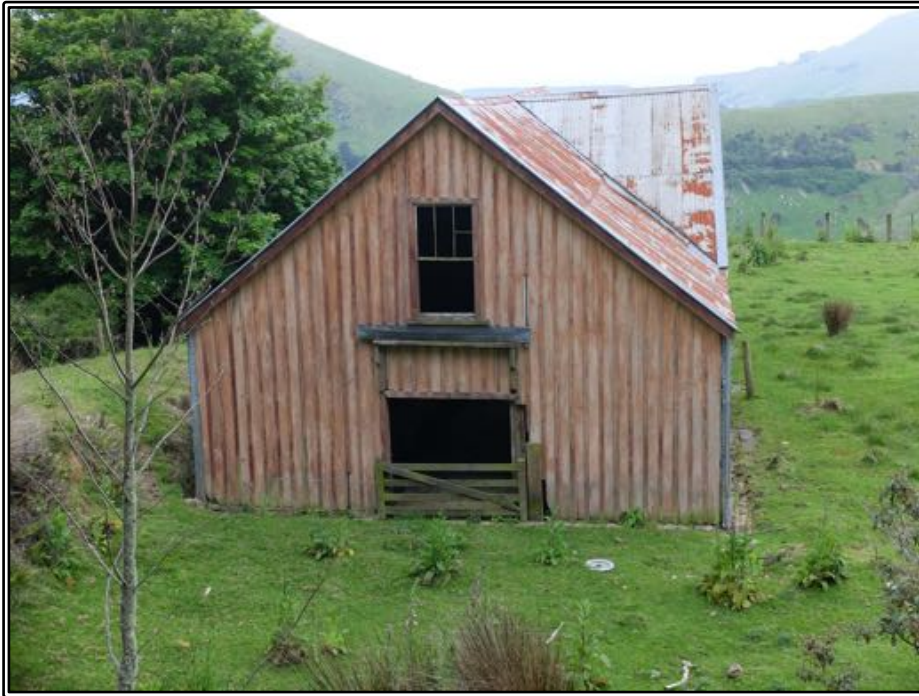
As already stated, the original board and batten cladding is only in place on the western end wall, but here it is complete and in reasonable condition (providing an excellent pattern for what the rest of the building should look like). The rest of the walls are clad in vertical sheets of corrugated iron, possibly installed in the 1970s (based on photographic evidence). The framing inside still has evidence of the placement of windows and louvres that were once present. The roof is also corrugated iron, and although it is not known if these sheets are original, it is likely that it was originally in this material. The two valleys on the dormer extension to the south are failing and leaking, causing decay in the structural timbers beneath.

Figure 156
The western wall of Larnach's byre. The board and batten cladding is original, and all four walls were once clad this way. Note the window with the remains of a 6-light sash still in place.

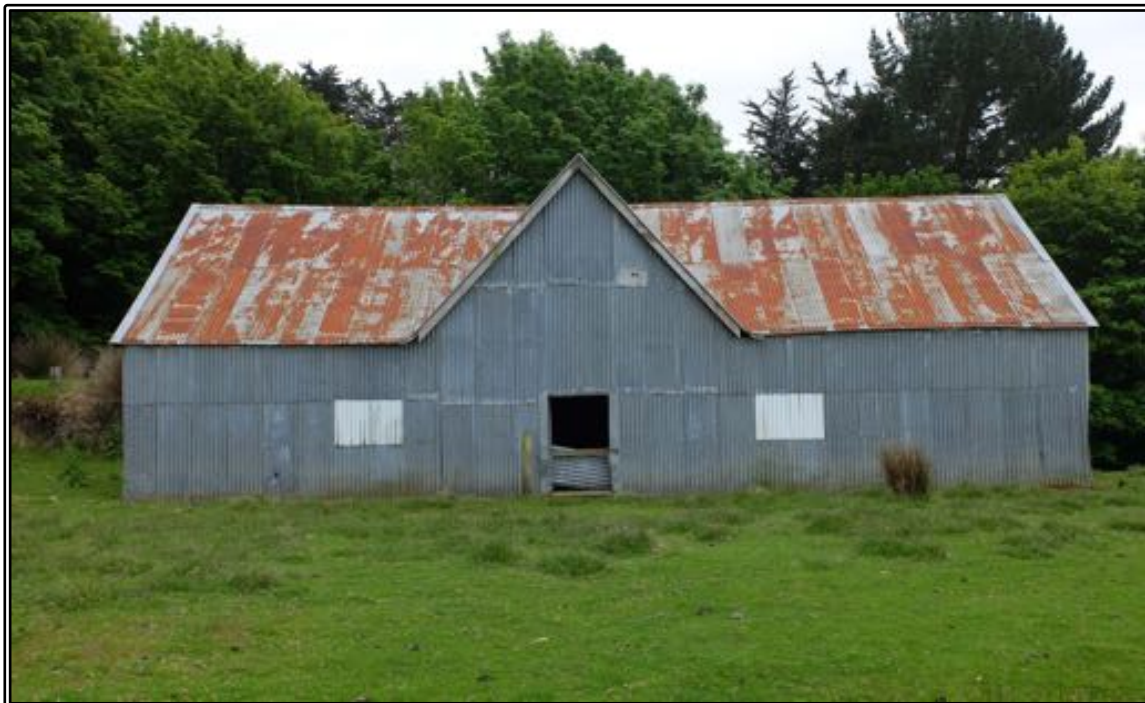
- All posts and piles mounted in the ground are rotten at ground level. It is unlikely that there is any fixing of the building to the ground: it is just sitting there.
- The wall structures are damaged in places, and in particular the fixings between the floor joists and wall are poor.
- The fixings between the rafters and walls are poor.
- The valleys are leaking and the valley structures are rotten.
- The floor structure is very lightweight, and not suitable for any weight on the upper floor. Many of the cow stall posts that the floor relied upon for support have been removed.
- The wall and roof cladding are supplying much of the structural strength of the building.
- The site drainage has been reinstated, but the footings are still too damp. The drainage will need to be improved.

Figure 157
The south wall of Larnach's byre.

A structural engineers report and remedial advice is required urgently. Some basic work (such as securing the rafters to the walls and repairing the valleys) would stabilise the building, but more intervention will be required.

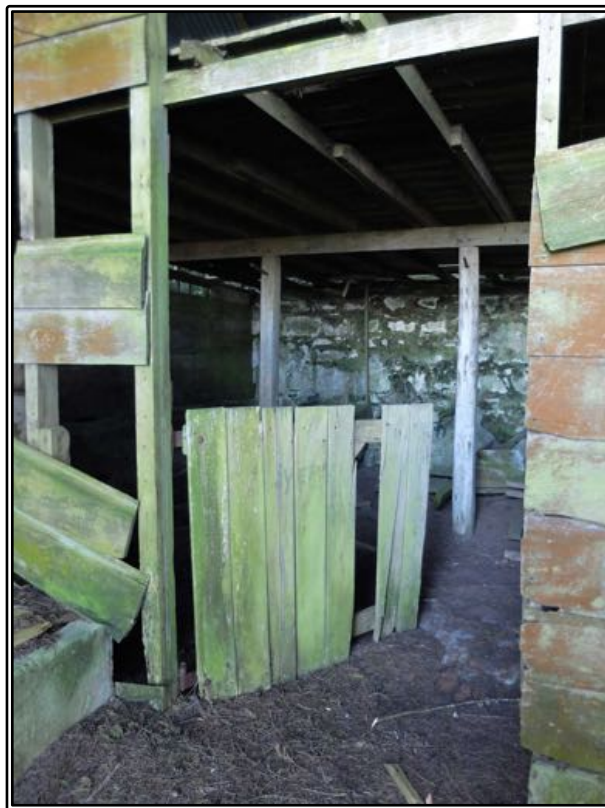
Figure 170
The stable door in the front (east) wall in 2017. Most of the vertical slats have now (2020) fallen off.

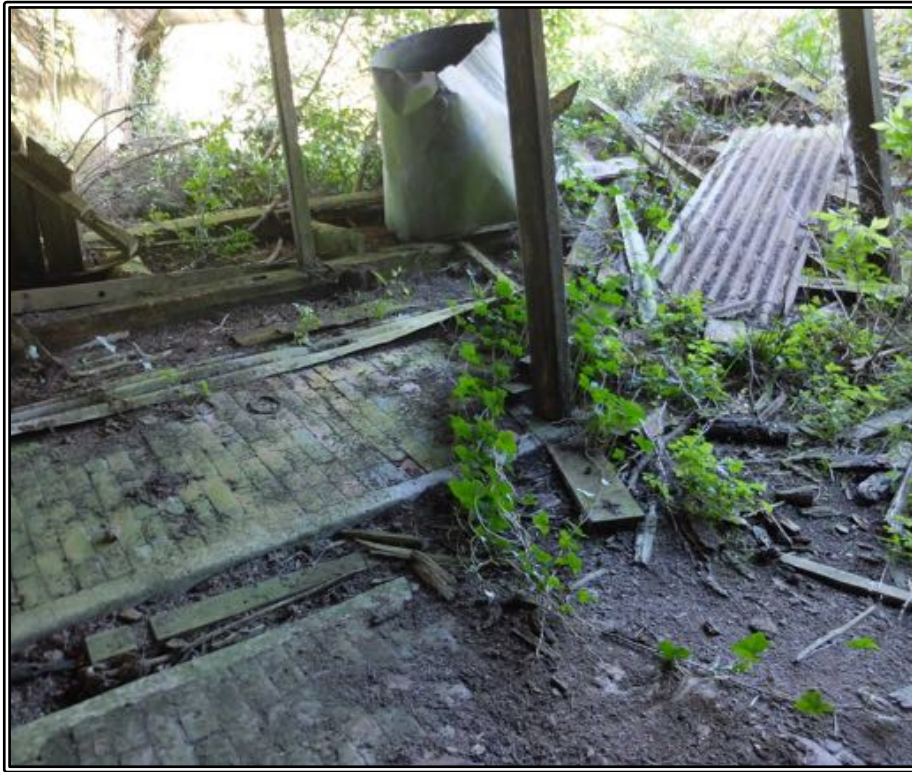
Figure 177

The well-made brick floor of Riddell's byre, with one of the drains in the foreground. The structure to the right (south) of this view has completely collapsed.
