HEREWEKA HARBOUR CONE

CONSERVATION PLAN
2020
PETER PETCHEY & JILL HAMEL

HEREWEKA HARBOUR CONE
OTAGO PENINSULA
CONSERVATION PLAN
2020

PETER PETCHEY
SOUTHERN ARCHÆOLOGY LTD.

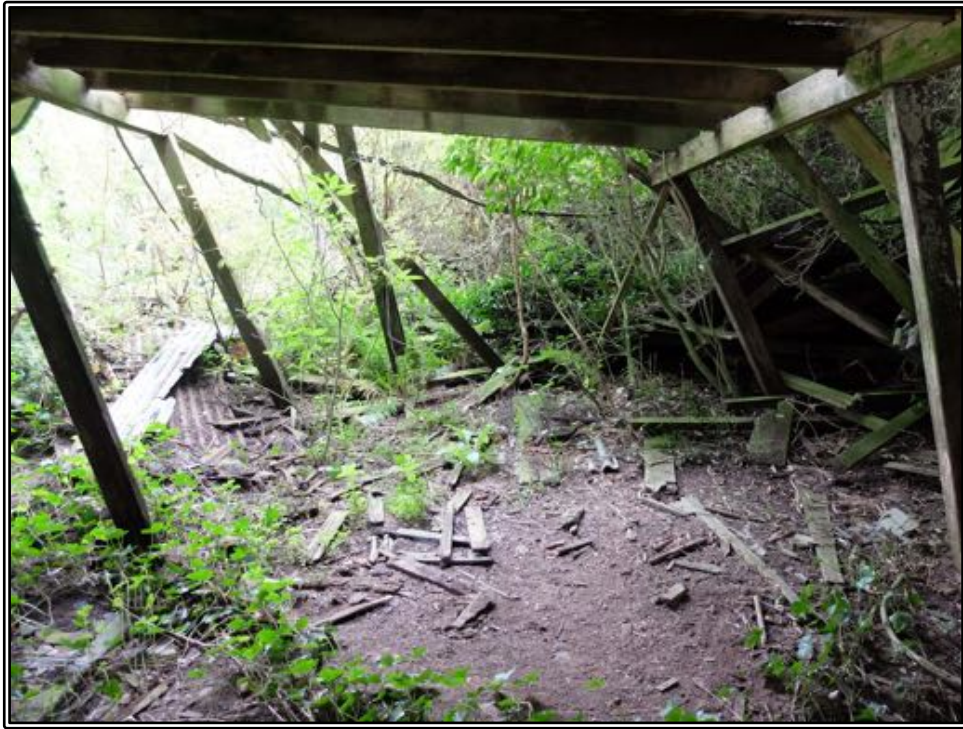
The building has now partially collapsed and the surviving section is in very poor condition, with macrocarpa branches from the overgrown farmstead trees bearing down on the structure. The southern end of the building (the byre) has been mostly demolished by a fallen tree, and only the centre section (the stables area) still stands to its full height, but the entire structure is unstable. There are large holes in the roof, areas of missing wall cladding, missing floorboards in the upper storey, and widespread decay in structural elements.

Figure 179
The cow byre, looking south into the collapsed portion of the building.

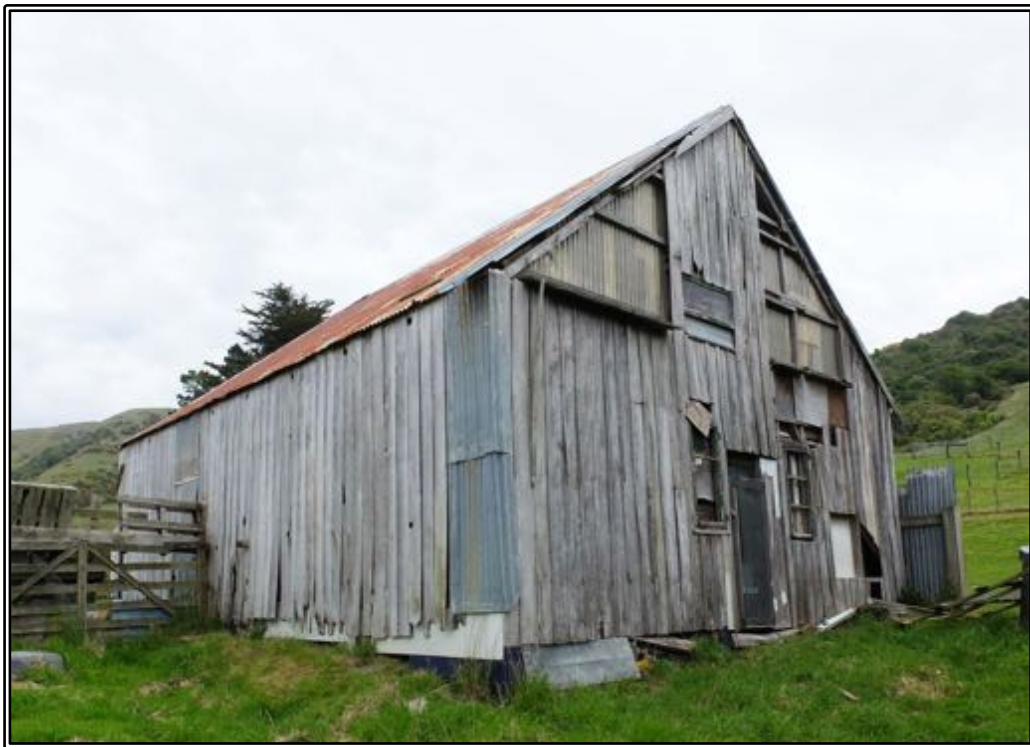
Figure 185
The east and north walls of Roger's byre. The original vertical board and batten cladding remains largely intact on these two walls. The cladding in the gable was probably cut away and replaced with transparent plastic sheeting when the byre was used as a chicken shed.

The byre is generally in sound condition, but requires both remedial and maintenance work. Some weather proofing work was carried out in 2017 (including replacing guttering, and patching holes in the walls with iron sheets), and a modern extension on the SW corner was removed that year as well, and the opening covered with corrugated iron. The building is essentially weathertight at the moment, but the corrugated iron roof is very old and is likely to be leaking slightly, and will get worse. The timber ground piles, while sound above ground level, are likely to be decayed below ground, and investigations will be required to determine their condition. But overall the building is in sound restorable condition.

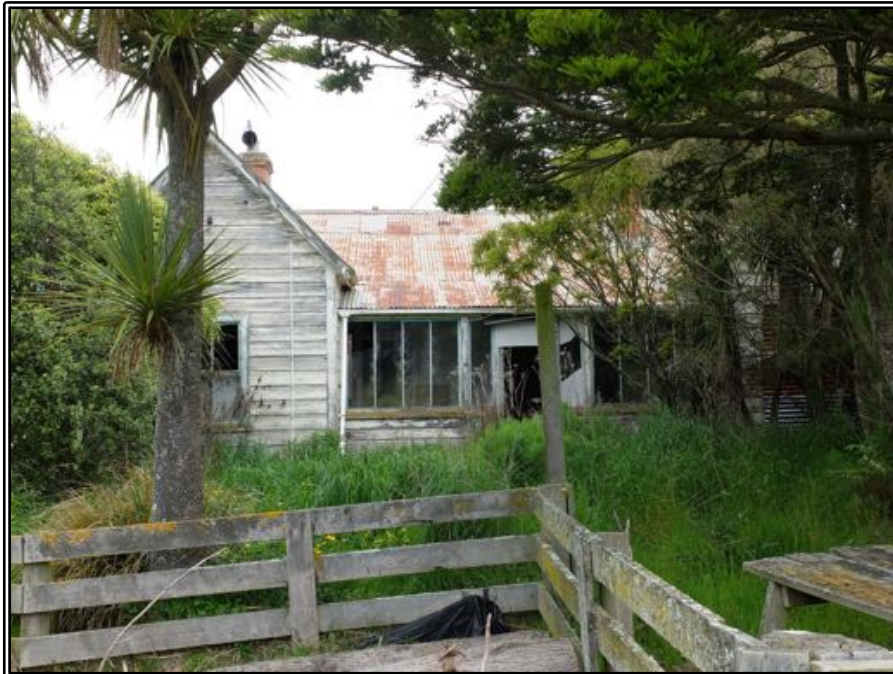
Figure 193

However, the house as it stands is in very poor condition. Several windows have been cut out of walls, probably using a chainsaw, and the openings roughly boarded over. There are numerous leaks in the roof, which have cause rot in places in ceilings, walls and floors. Woodworm infestation is apparent in several rooms. While not beyond repair, this would be an expensive undertaking.

The front of Roger's house, with one gable end and the enclosed veranda visible through the overgrown front garden. The house faced towards the north, into the sun and towards the farmyard.

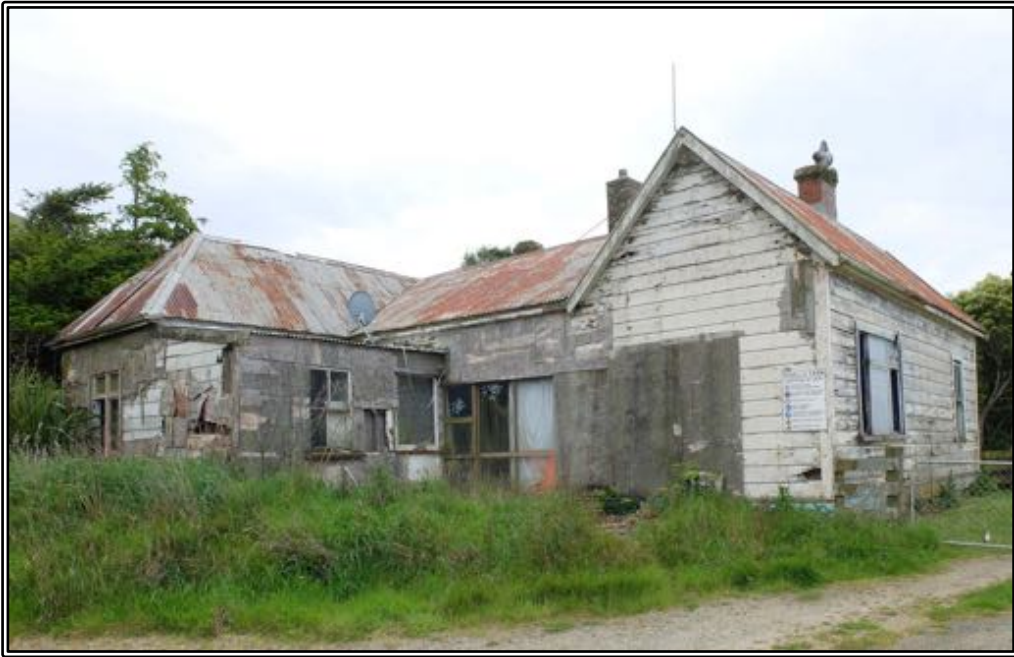
Figure 195

The rear of Roger's farm. This elevation is in very poor repair, and several windows have been chainsawed out and the openings boarded over.

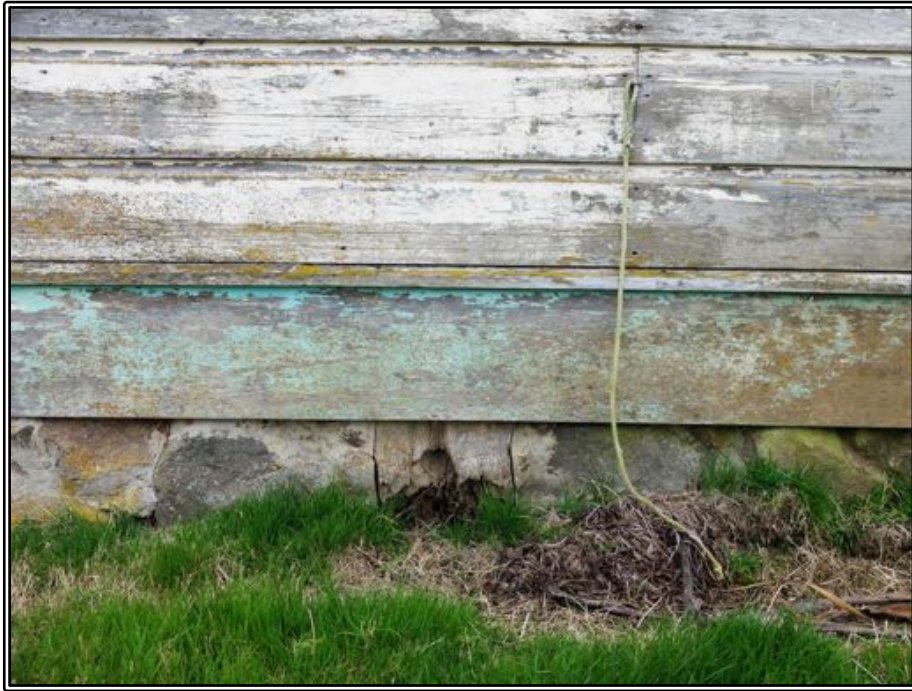
Figure 197
Detail of the base of the east side of the house, showing the hardwood piles and bluestone used in the foundations.

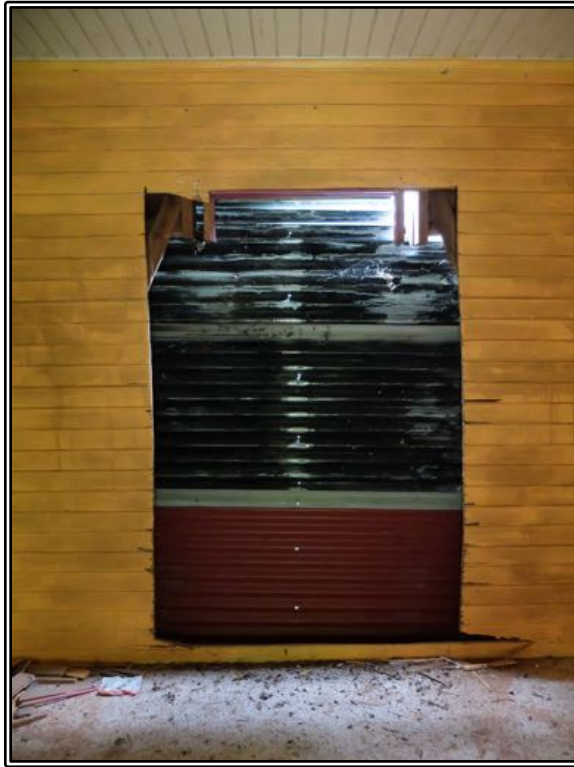
Figure 199
Inside the western bay return of the house, showing where the window has been cut out and the opening covered with sheets of roofing iron.

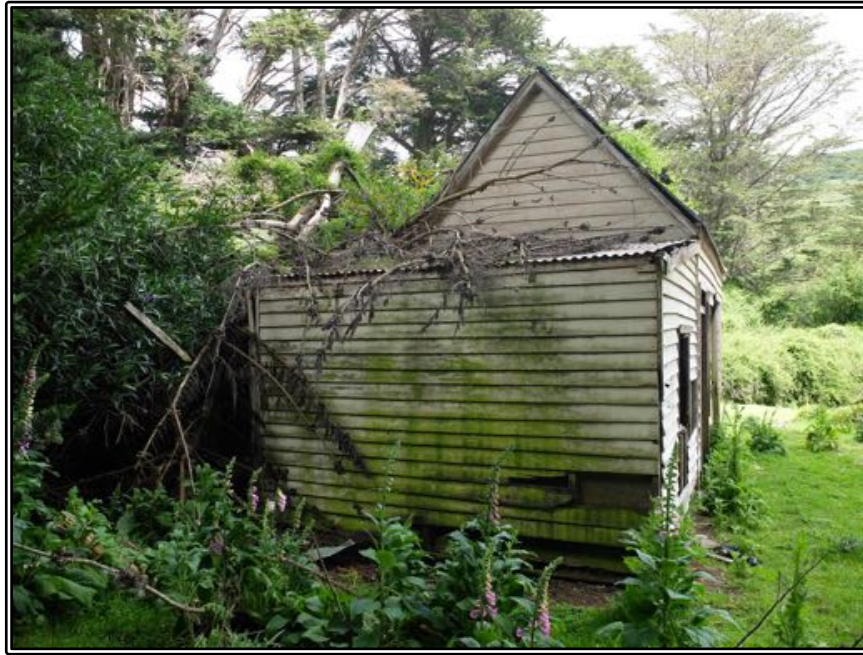
The cottage consists of the original timber cottage, with lean-to additions to the east side and rear (south). The rear additions are in very poor condition, and have been partly destroyed by falling macrocarpa branches. The east side addition is still intact, but appears to have suffered from much worse timber decay than the original section. This is probably due to two factors: a shallow roof pitch (which does not self-clean and shed water rapidly) and the use of different timber (commercially milled). The overall combined structure measures 30 feet 6 inches by 20 feet (9.3m by 6.1m).

Figure 203
End view of the eastern end of Stewart's house, showing the later addition and the mass of fallen tree branches on the rear part of the structure.

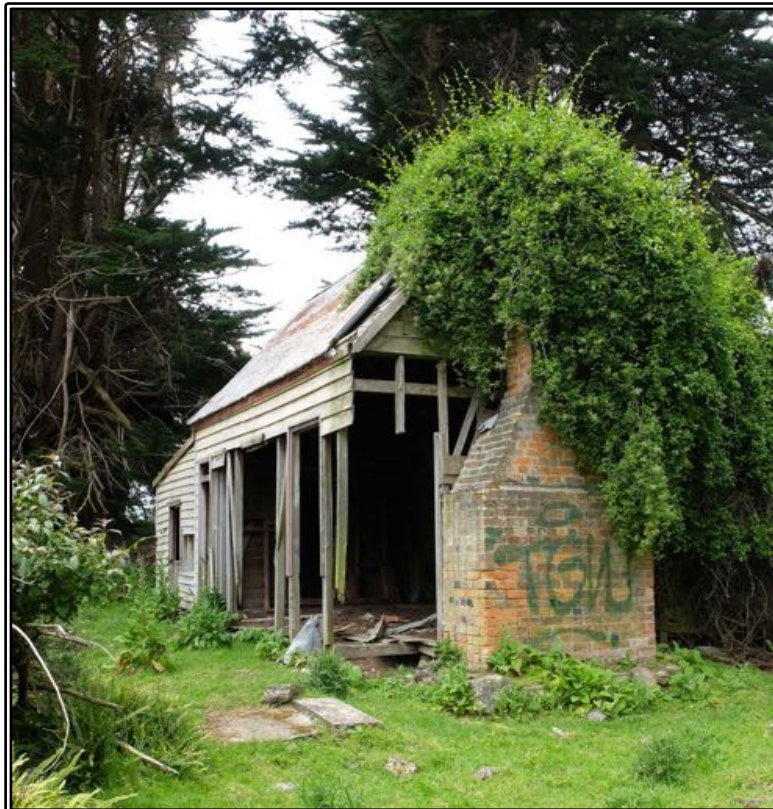
The cottage is in poor condition due to the missing elements, but the remaining fabric of the original cottage is in extremely good condition given its long-term exposure. The timber has not yet been identified, but is likely to be broadleaf or totara, given its durability. This means that despite the missing elements the structure is still solid, and is capable of being stabilised and/or restored.

Figure 204
The eastern end of Stewart's cottage, showing the large brick chimney and perilous state of the front framing.

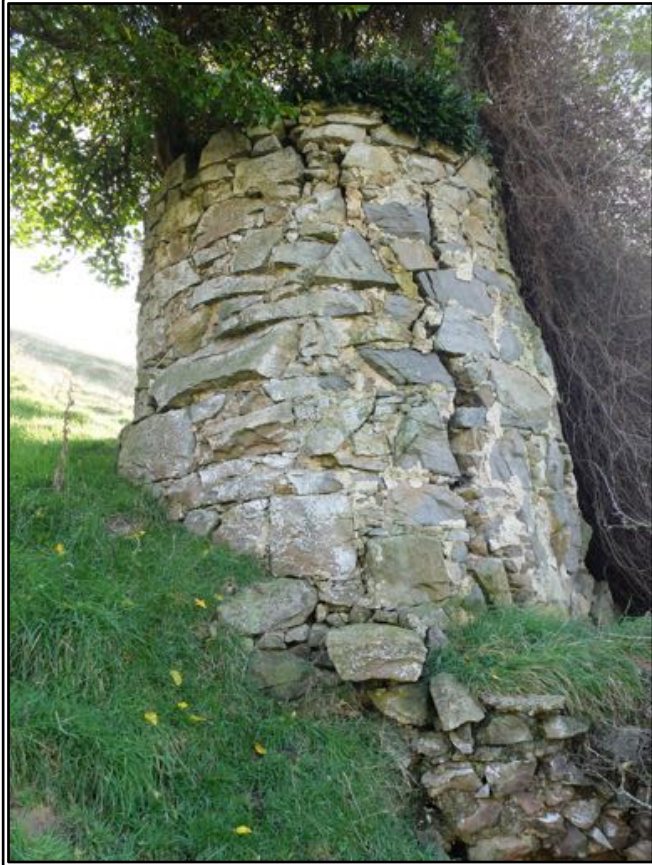
Two large cracks are visible in the sides of the bowl. One is ca 8cm at its widest and is also being pushed out by ca 5cm. A second, larger crack has created a large gap of about 20cm halfway down the charging bowl, also with an oblique sideways movement approximately 5cm. A tree growing out of the top of the charging bowl is at least in part responsible for the cracks, and the root ball has created a bulge in the southern side of the bowl. A root growing through the masonry at the base of the central eastern face has made a large void in the masonry approximately 15cm wide by 45cm high.

Figure 213
The charging bowl of the limekiln.
Note the crack running the full
height of the structure.

To stabilize the charging bowl, reinforcement with a steel brace, capping of the top courses and repointing in the stonework will need to be done. The large cracks should be mortared and monitored after tree removal to examine if there is any movement in the cracks. The oblique movement of the crack should also be monitored after tree removal, as pressure from the tree's root base is the likely cause of the bulging out of the drum causing the crack to move outward as well as apart.

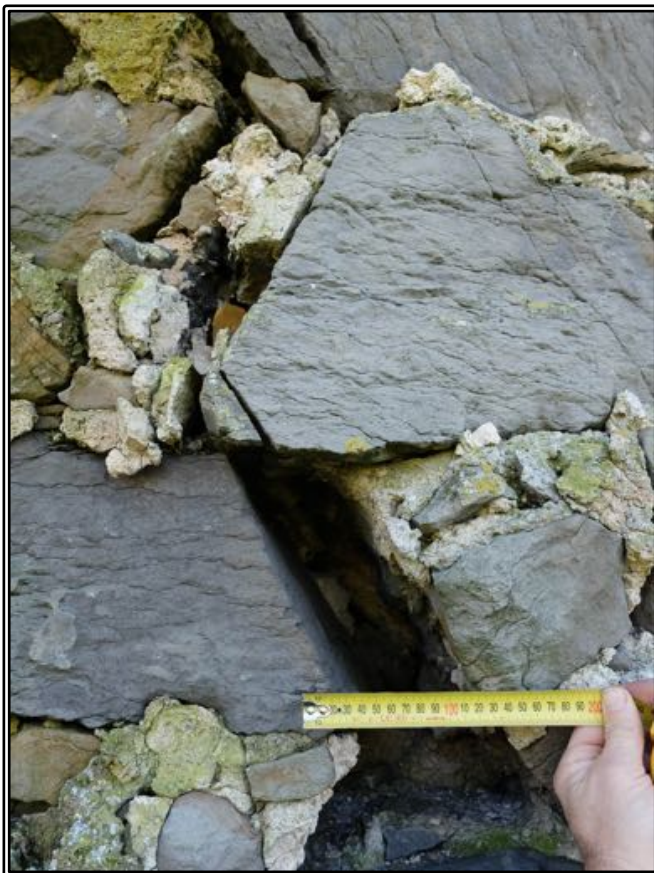
Figure 214
Close-up of one of the cracks in the
charging bowl.

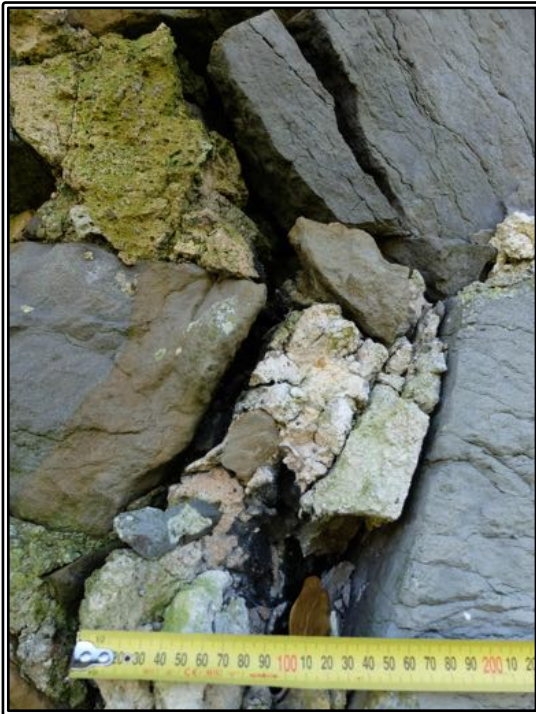
Figure 215
Close-up of a crack in the charging bowl. The two layers of mortar in this image indicate that the walls of the kiln were moving while it was in-service, and regular repairs and maintenance had to be carried out.

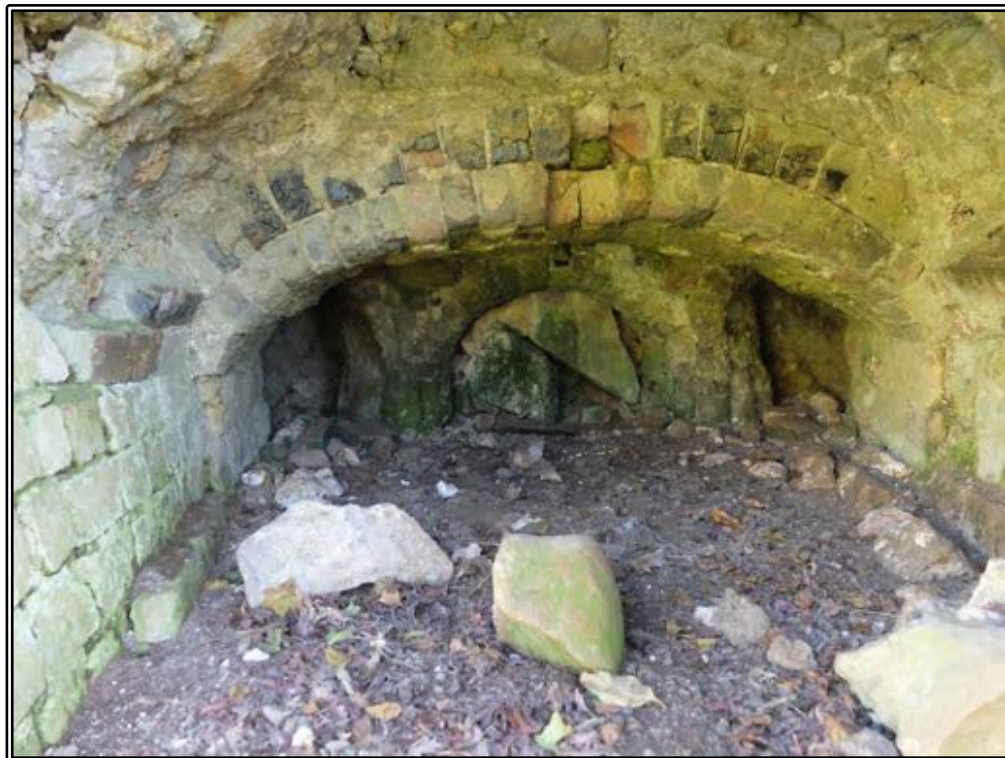
The outer southern wall of the firebox has been pushed out by tree growth, which has destroyed a large section of the roof and is pushing the southern wall out on an angle of approximately 22° to the south. The stonework in the outer southern wall is very unstable. The larger quoins which are missing in this section, are likely the blocks strewn down the hill just south of the firebox entry. A large slab which is the entryway platform to the firebox and the roof of drawing eye compartment is possibly concrete. A dressed limestone step leads up to the concrete platform.

Figure 217
The firebox, showing the brick firebox arch and the three stoke holes.

The southern wall of the firebox will need to be restored as it is danger of collapsing. The stone masons can replicate the masonry work from the northern wall of the firebox, which is still in a relatively good condition. A temporary fence should be put around the lime kiln which is vulnerable to damage from cattle.

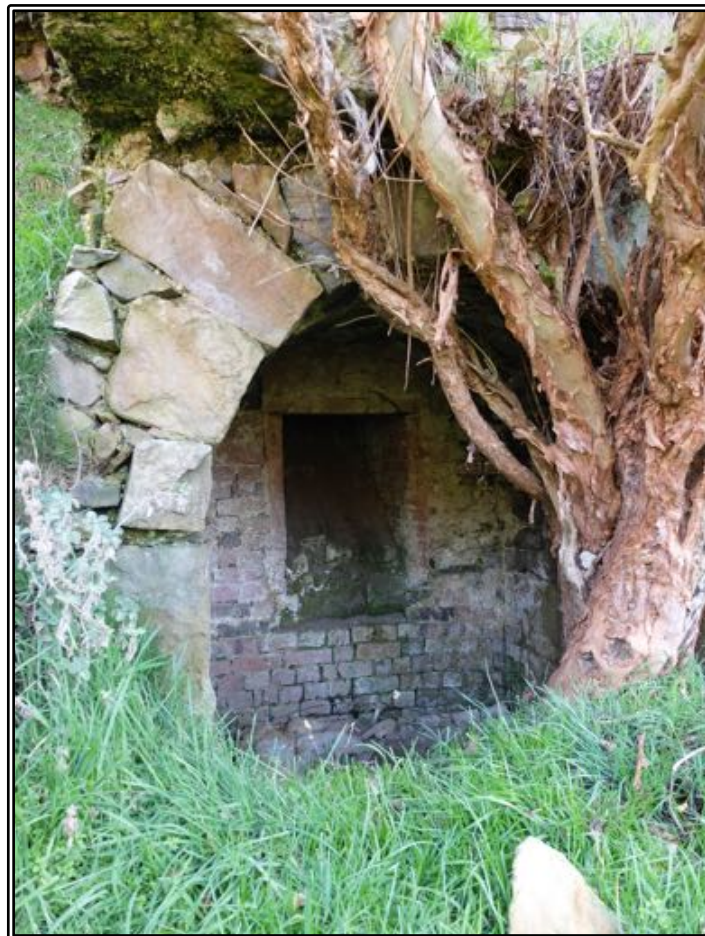
The southern outer stone wall of the drawing eye compartment was obscured by vegetation. The ground in around this wall has been filled in about a metre high against the wall which is part of the entryway to the drawing eye compartment. The floor is covered in vegetation and the remains of a dead sheep. A tree is growing at the eastern base of the structure, in the entryway to the drawing eye chamber. This tree is destroying the apex of the stone arch entryway to the drawing eye compartment and has likely got a root base which extends under the foundations of the structure.

Figure 218
The drawing eye.

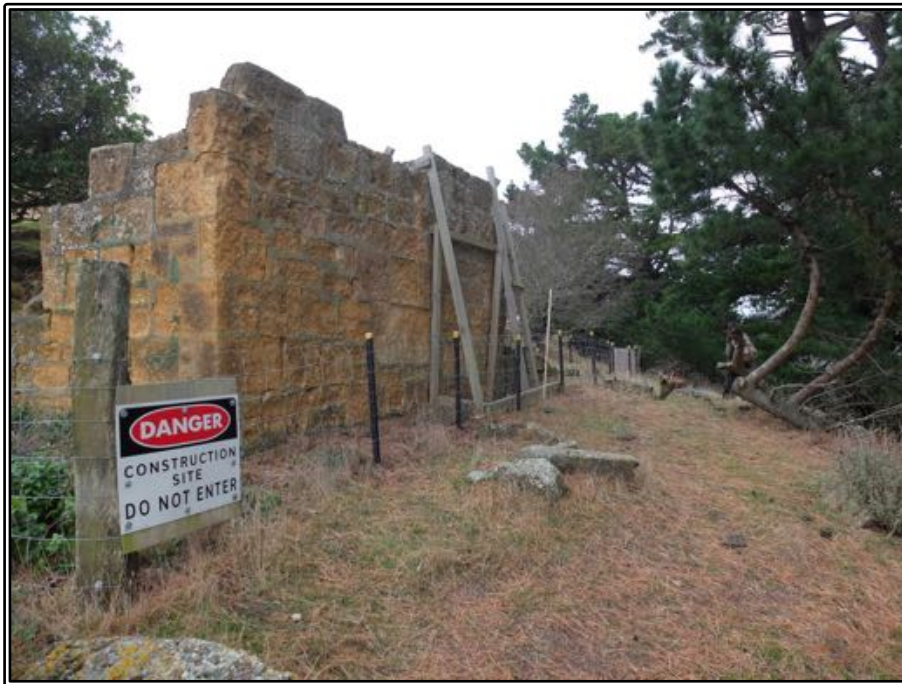
In several places tree roots growing in the stonework have damaged the walls, and a small tree was growing out of the western wall. It has been cut out, but it is likely that damage has already been done. This wall has been propped from the outside to prevent collapse.

Figure 221
The end wall of Allan's house ruin in 2020 with timber props and safety fence in place.

At present Stuart Griffiths and Carl Murray are investigating suitable lime manufacture to undertake stabilisation of this ruin. Dismantling and reconstruction has been considered, but is not ideal from a conservation perspective due to the intrusive nature.

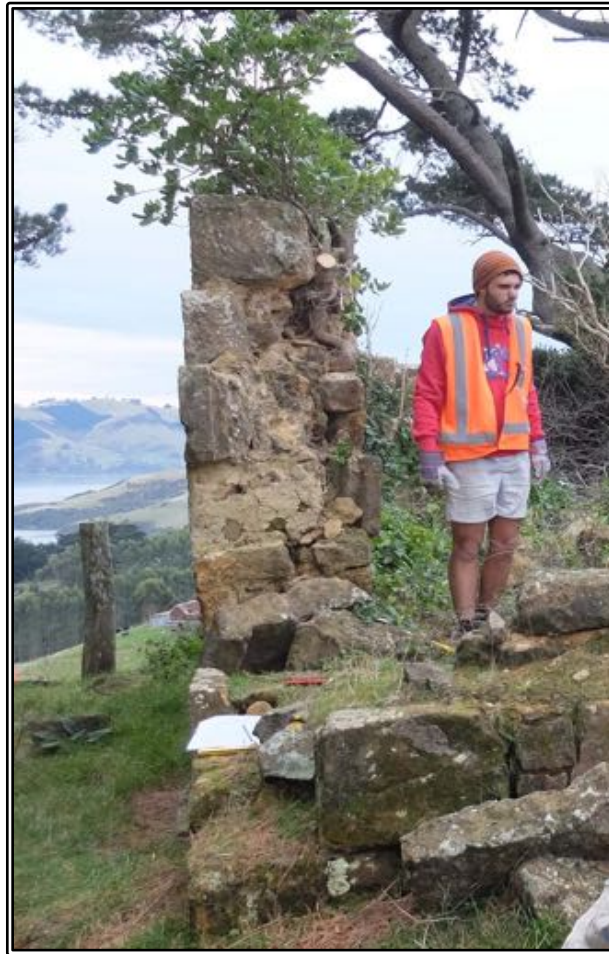
Figure 222

The end view of the standing wall of Allan's house ruin, showing how the wall was constructed, with facing stone and a rubble core. The splitting of this core due to tree root growth is one of the reasons the wall is failing.
